Structural Observation Report

Prepared for: [REDACTED]

Inspection Date: 5/7/2022

Prepared By: Zoey Tham, #24GI00217600

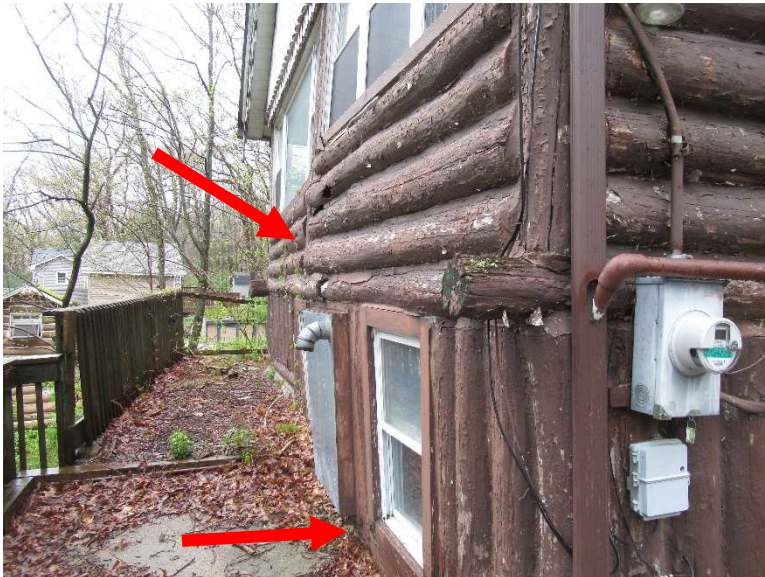
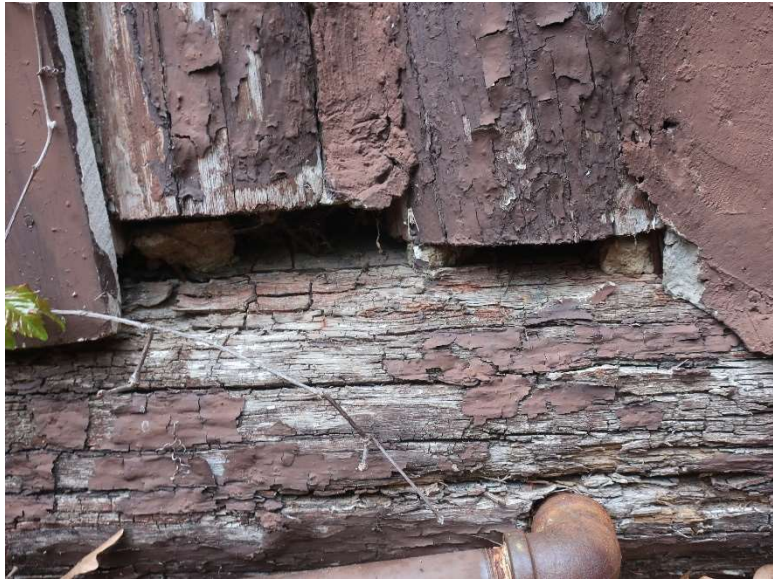
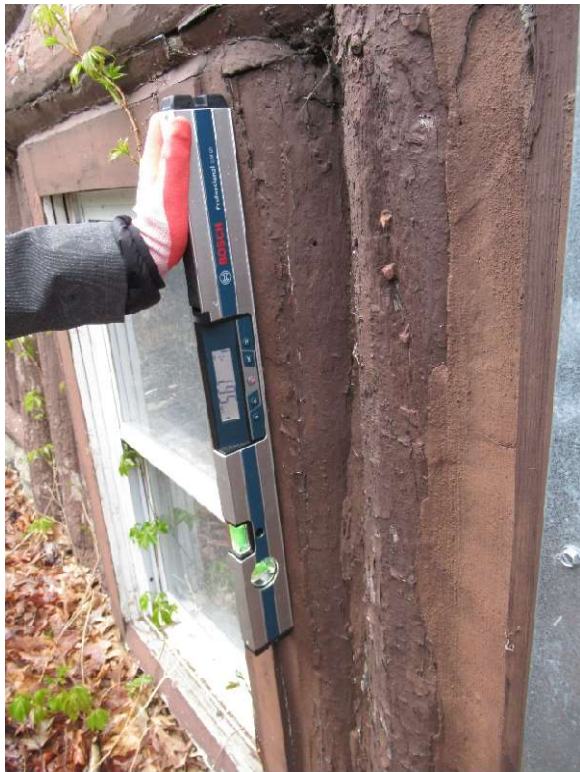
The bulging rear wall could be a result of building lateral movement and settlement. Based on our field observation, the soil elevation at the front side of the building is higher than the soil elevation at the back side of the building. The higher soil at the front side of the building would impose lateral load toward the rear side of the building. The building could have moved laterally when under lateral load and the deteriorated structural members and improper structural connection could not provide the adequate support.

Observation #1: The rear wall of the building appeared to be bulging outward with an approximate measured slope of 2 inch per foot. Some of the vertical logs were not properly bearing on the base horizontal log.

We recommend demolition and reconstruction of the building rear wall.

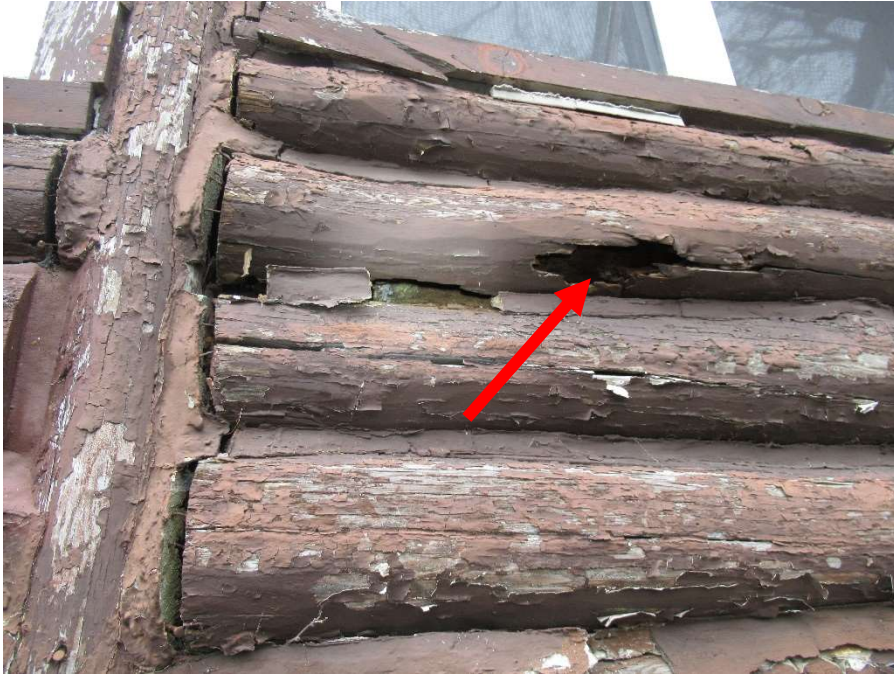
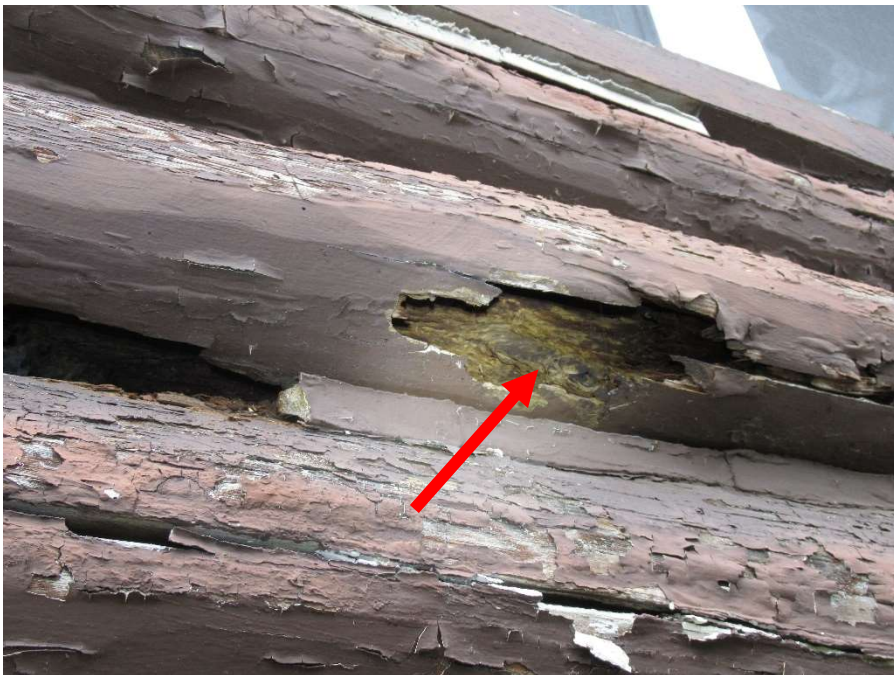
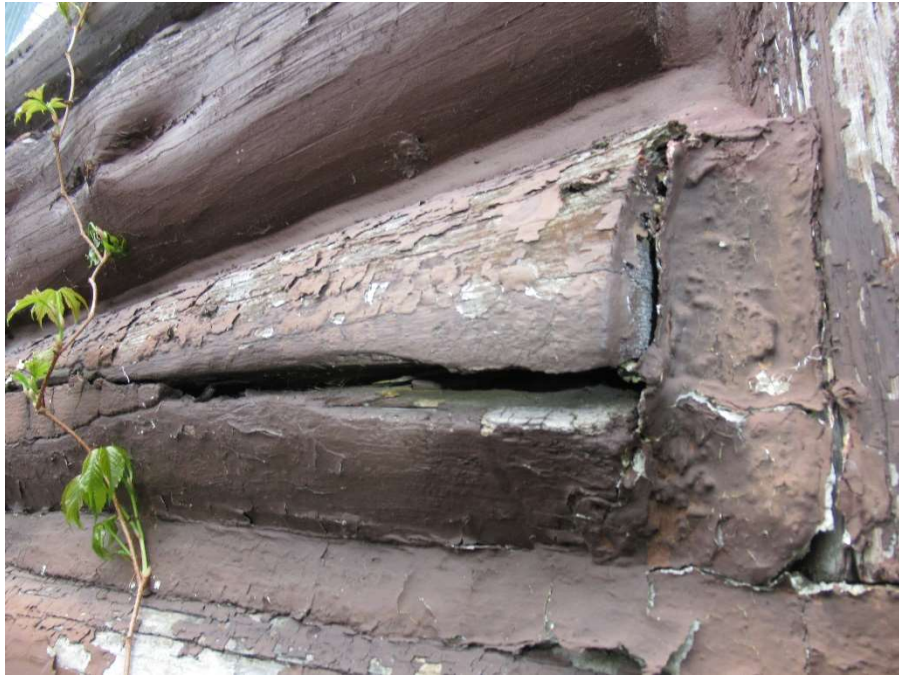
The vertical and horizontal logs in the structure are load bearing elements. Deterioration in the logs implies reduction in their load bearing capacity. The logs with severe section loss are compromised and have lost their ability to properly transfer load from the roof and floor to the foundation. For example, the deteriorated horizontal base log on top of the rubble foundation might no longer adequate to support the loads imposed from the vertical logs and could cause overall building settlement above the foundation.

Observation #2: The horizontal logs in the rear wall were significantly rotted with large cavity inside the log. Some of the logs have large horizontal split.

The deteriorated logs and failed nail/screw connections had weakened the structural capacity and integrity. We recommend removal and replacement of all the deteriorated and damaged logs in the building.

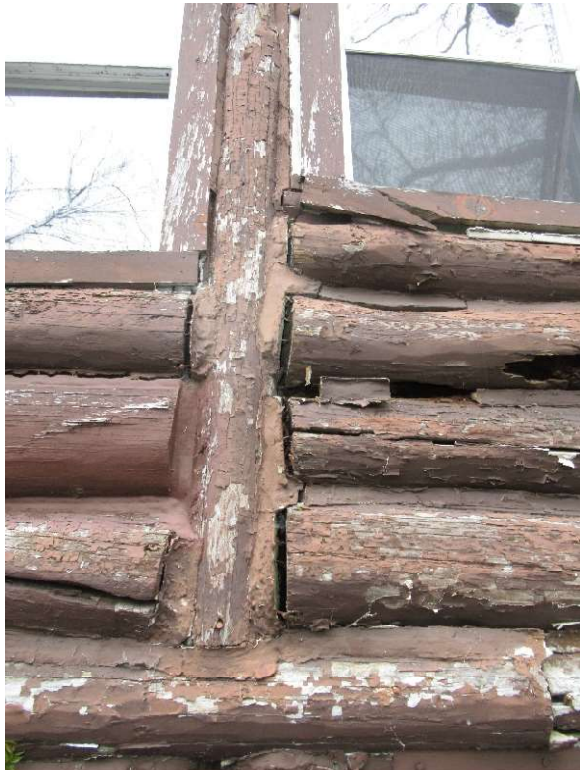
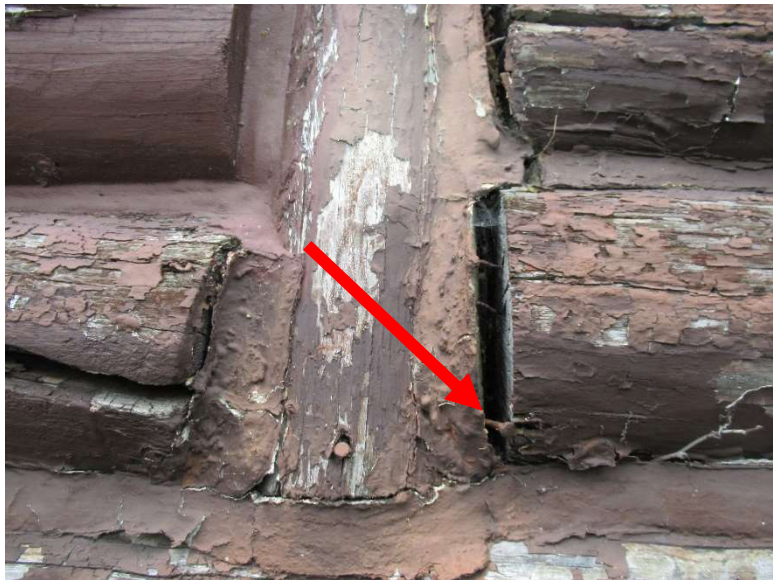
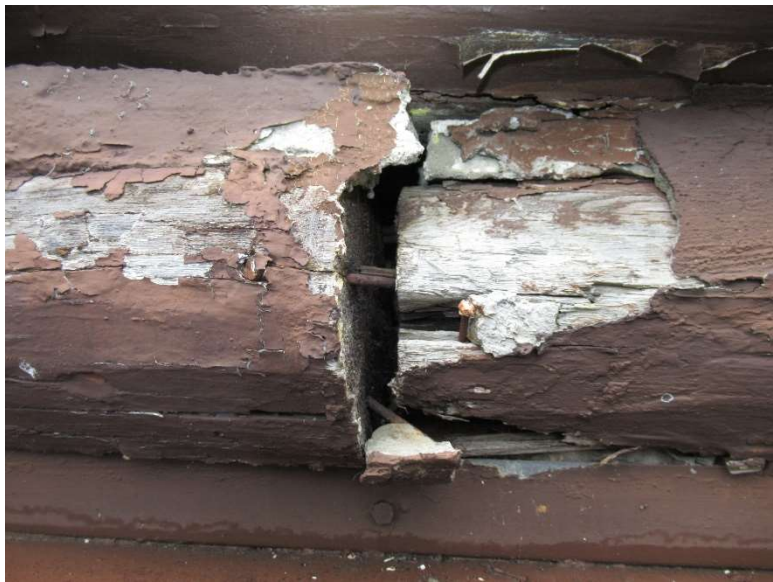
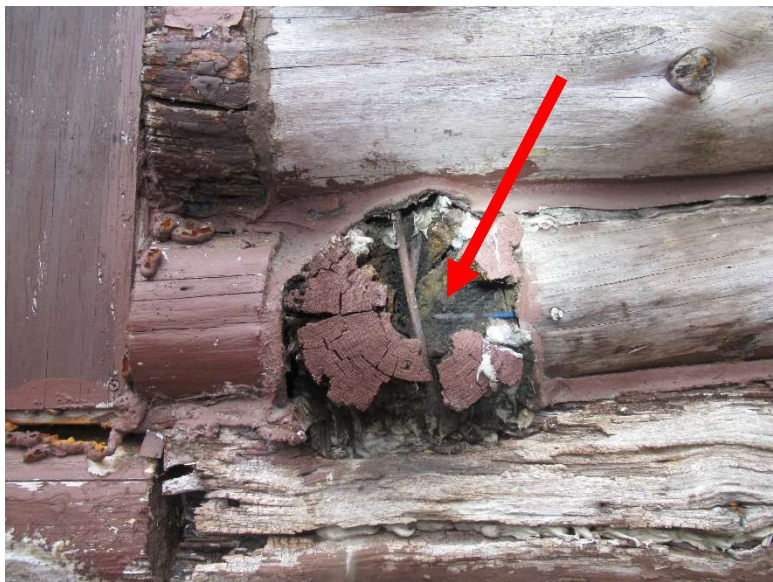
The deterioration and section loss in the logs had also led to the failure of their nail/screw connections, as the nails and screws can no longer engage the logs with section loss.

Observation #3: Multiple nail/screw connections in the log wall were observed to be failed.

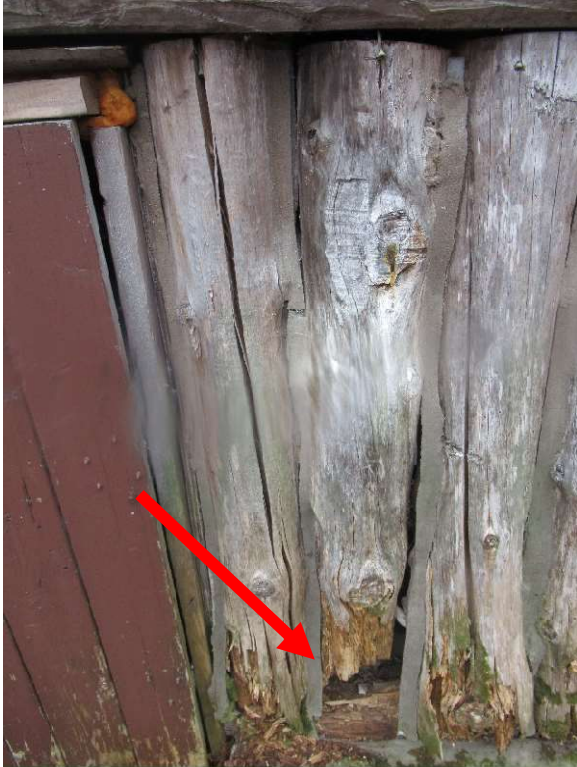
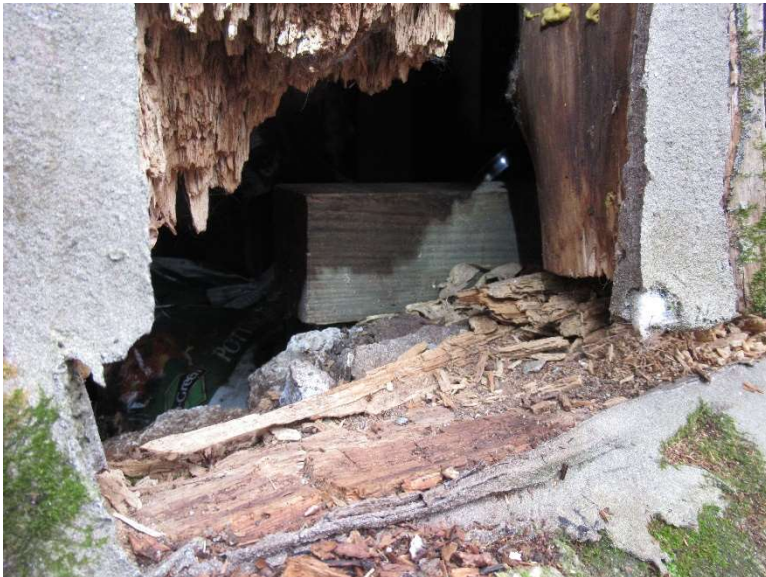
Observation #4: Multiple vertical logs at the side face of the building near the basement entrance door were significantly rotted at the bottom. The horizontal base wood sill was also severely deteriorated. A hole was observed at the bottom of the vertical logs.

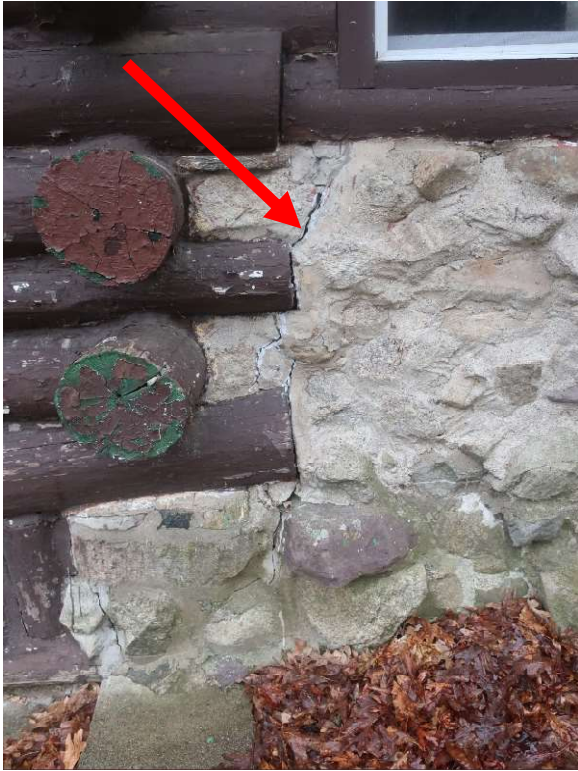
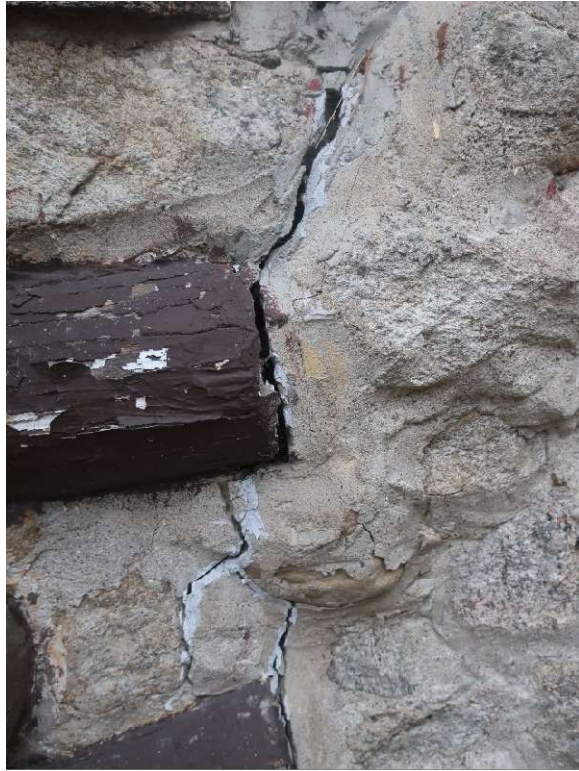
Observation #5: A large vertical crack (approximately 1/2" wide) was observed in the rubble stone foundation wall at the left side of the building.

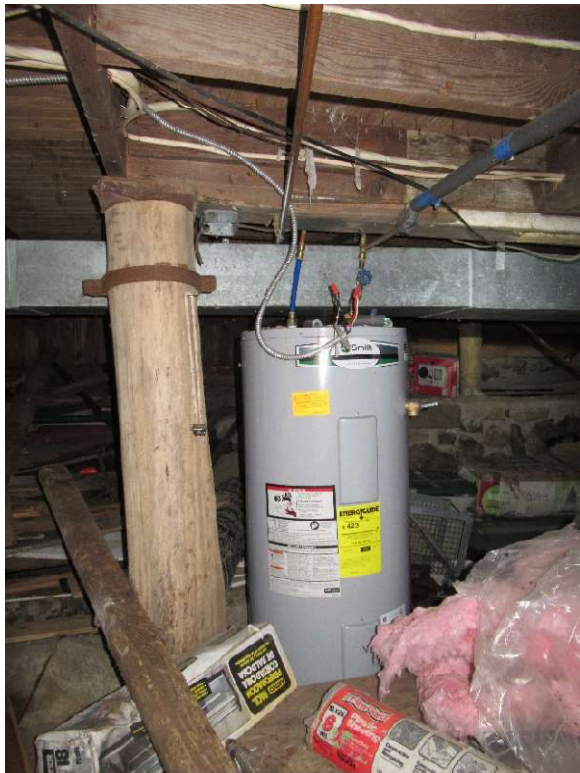
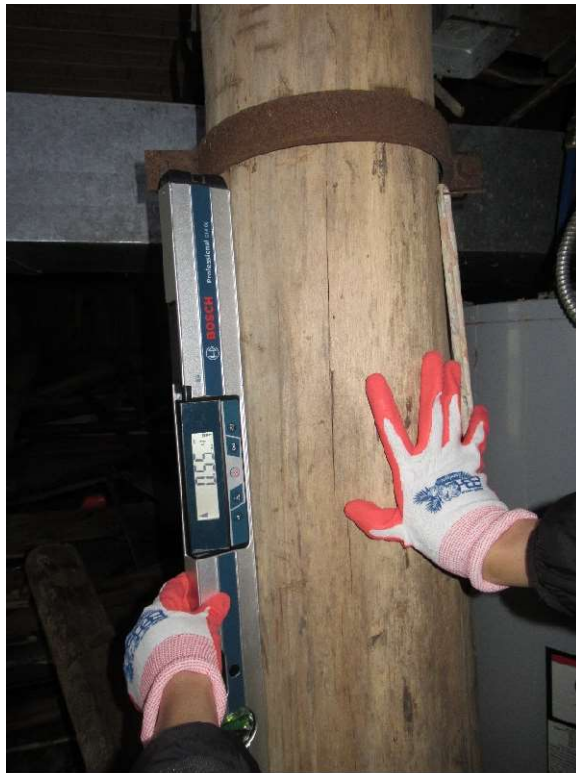
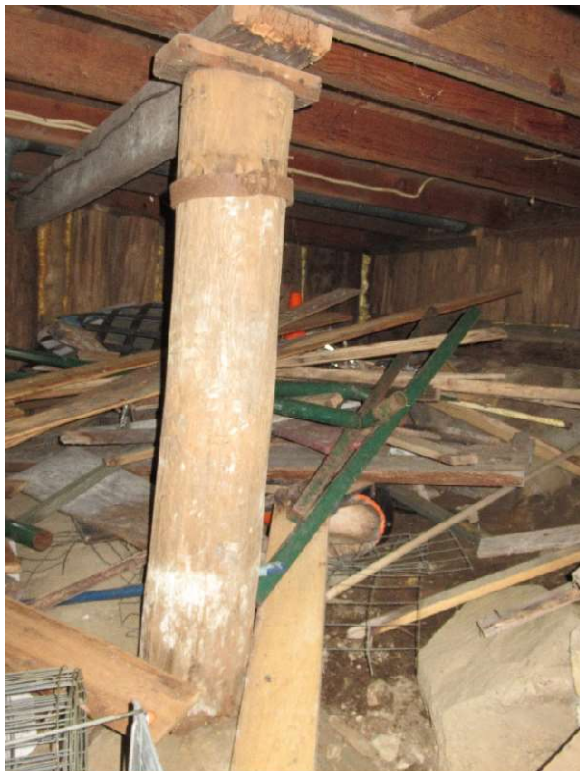
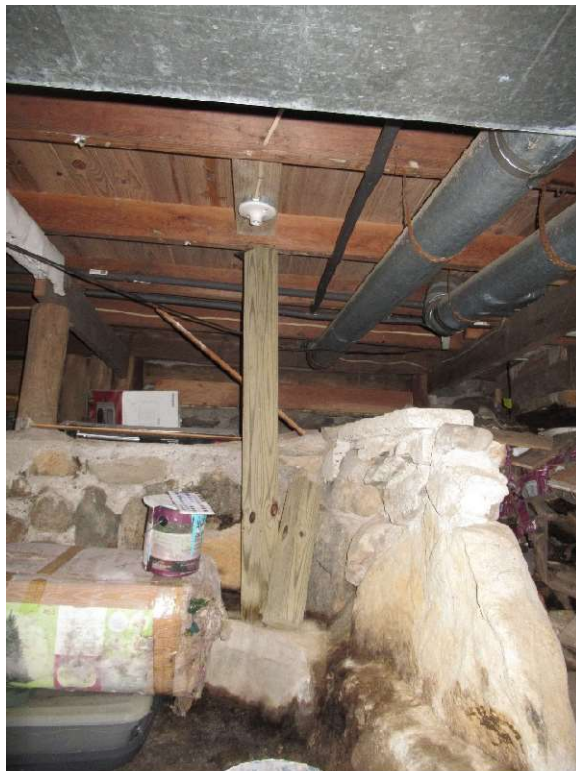
The wood posts are the major gravity load carrying members in the building. The observed damage in the base of the wood posts due to water and wood destroying insect implies reduction their load carrying capacity. Out of plumb wood posts imply improper wood post installation or lateral building movement. Further loading an out of plumb wood post would amplify the lateral displacement and could cause tipping or failure of the wood posts and the entire structure.

Observation #6: Multiple wood posts in the basement were observed to be out of plumb.

We recommend repair or replace the damaged wood posts, adjust all the out of plumb wood posts and installing additional lateral bracing between wood posts.

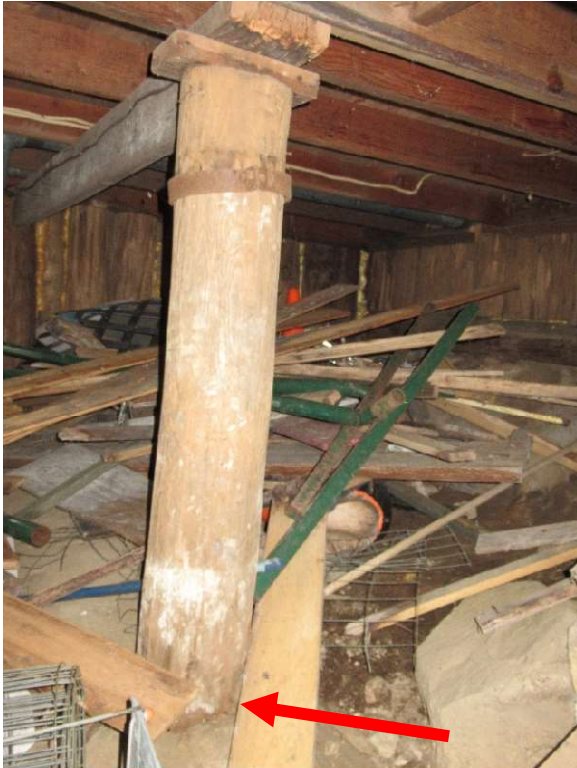
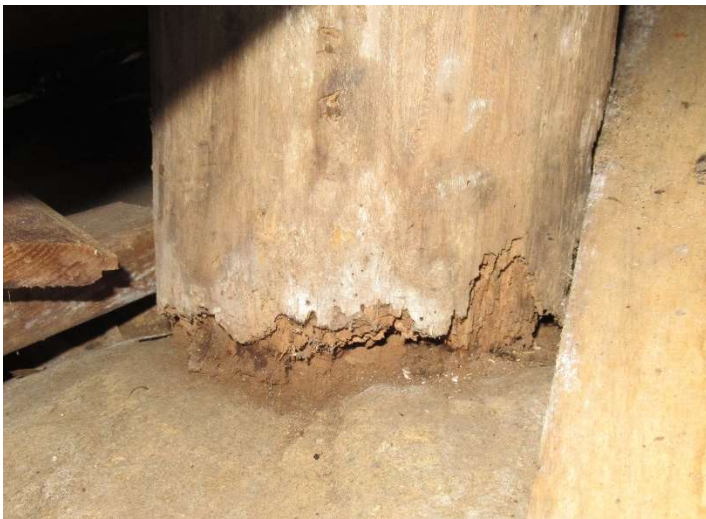
Observation #7: Some of the wood posts appeared to be damaged by wood destroy insect.

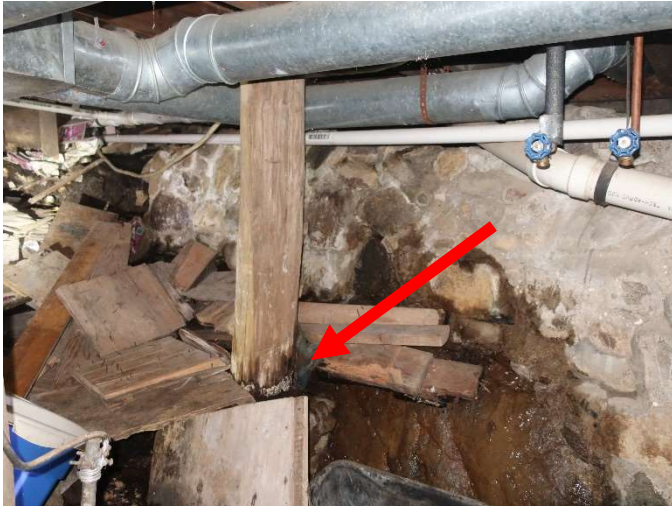
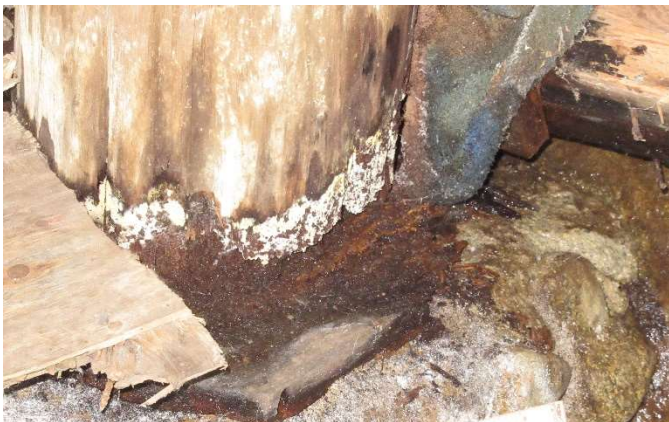
Observation #8: The bottom of one of the wood posts appeared to have significant damage due to moisture/water.

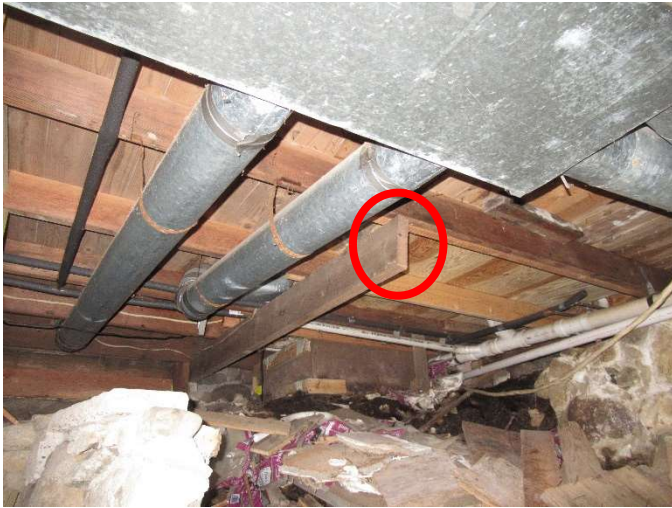
addition, multiple header joists were not properly connected to the load bearing logs. One of the header joists was not even supported at one end. These inadequate and defected connections could lead to building lateral movement and connection failure.

Observation #9: One of the 1st floor header beams appeared to have no end support.

We recommend installing new support at the unsupported end of the specific header joist, reinforcing the connections between the header joists and the logs and installing lateral bracing between wood posts as mentioned above.

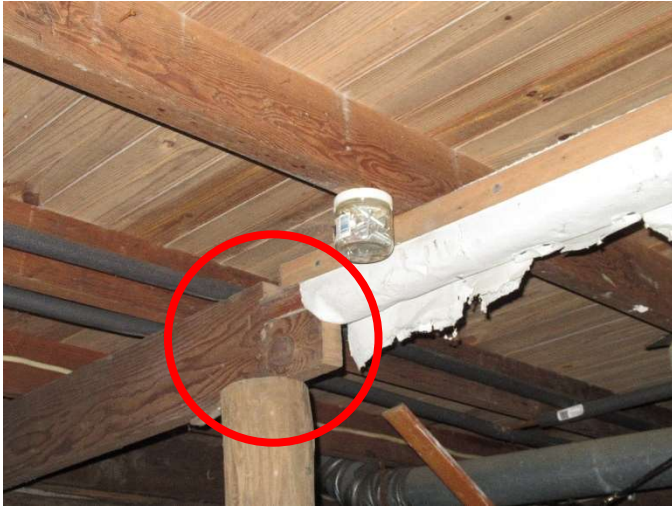
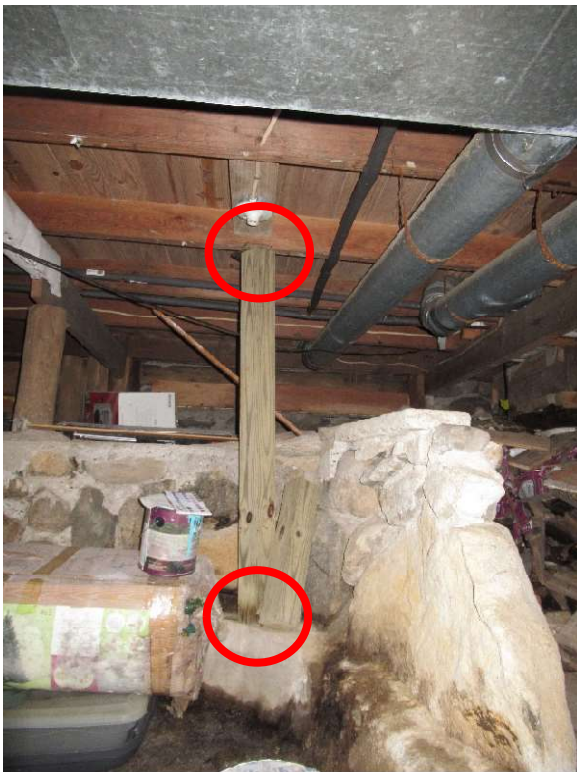
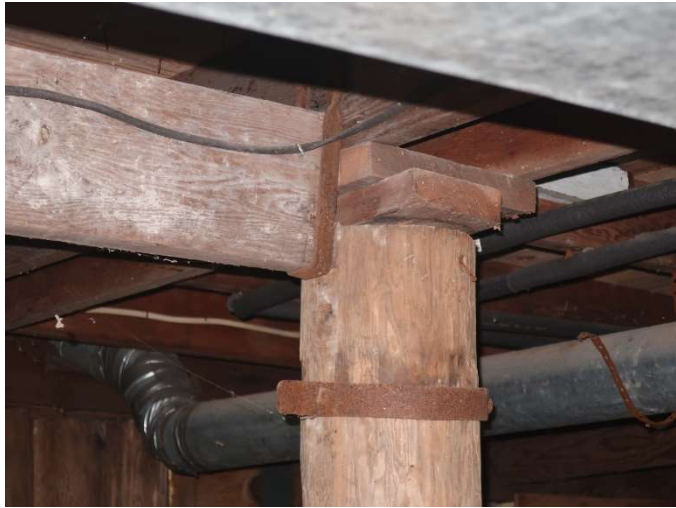
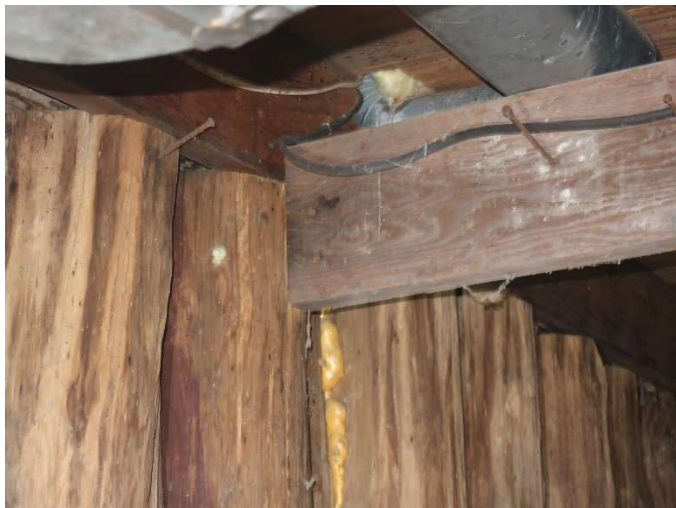
Based on our field observations, the header joists are typically bearing on top of the wood post section. This type of connection appears to be not able to provide adequate lateral support to the wood posts to prevent lateral movement. In

Observation #10: Improper connections between structural elements were observed in multiple locations.

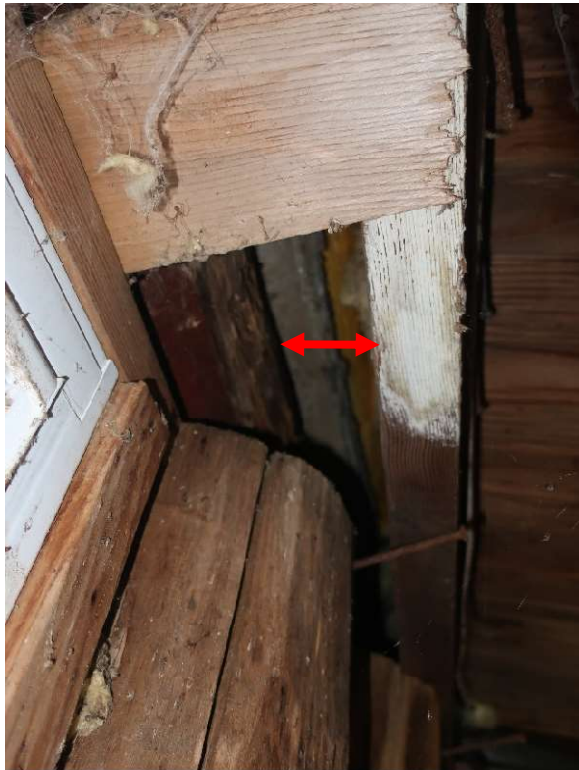
Observation #11: Header joist was not properly supported/connected due to rear wall bulging.

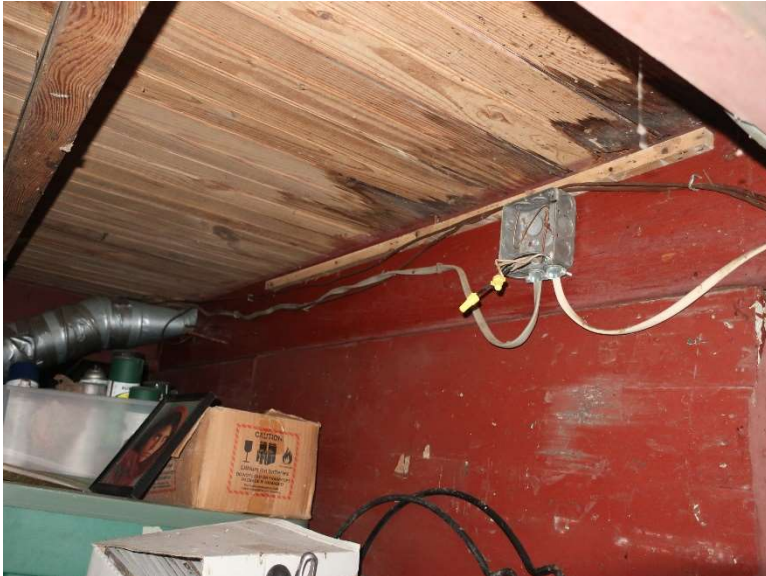
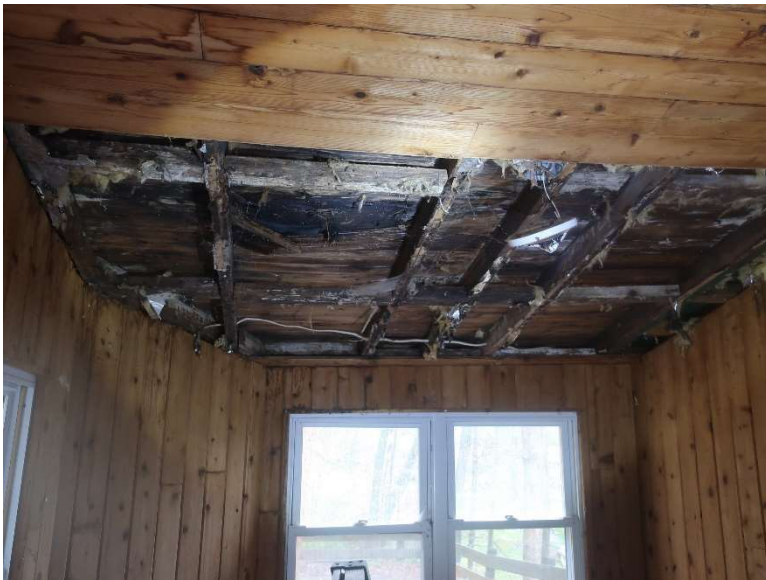
Active water leakage from the roof and water ponding on the 1st floor were observed near the front of the building. Water damaged roof sheathing and rafters implies weakened roof structure.

Observation #12: Some of the 1st floor and roof wood planks and roof rafters were damaged by water.

We recommend removing and reinstalling the damaged roof elements and install new roofing system to prevent roof structural failure and future leak.
