Home Inspection Report

Prepared for: [REDACTED]

Prepared By: Zoey Tham

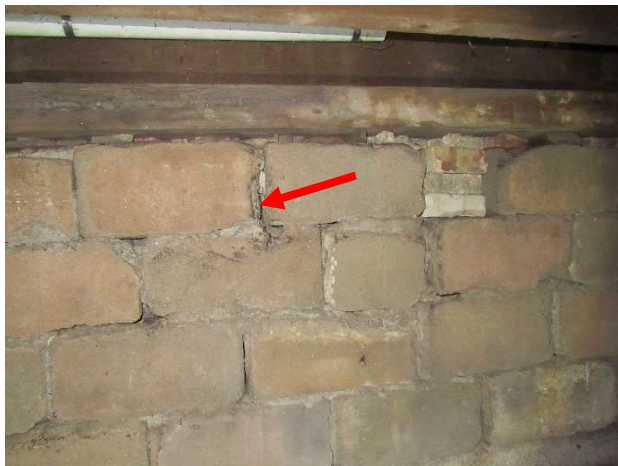
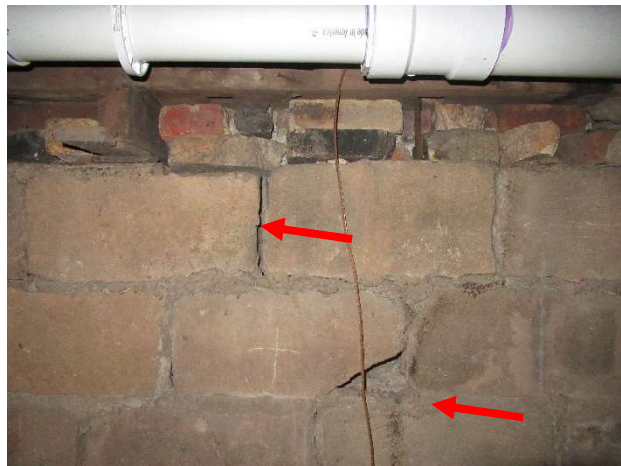
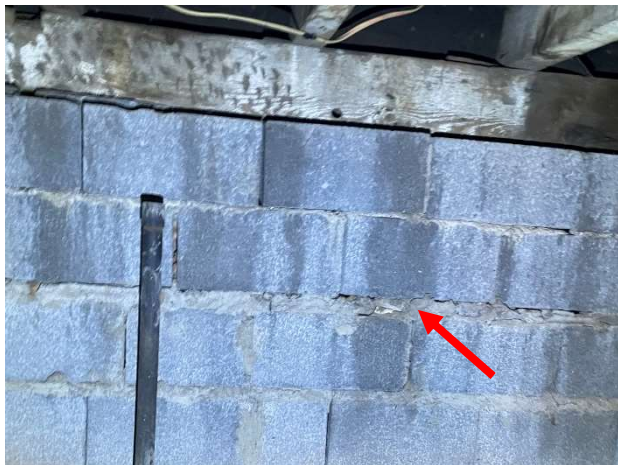
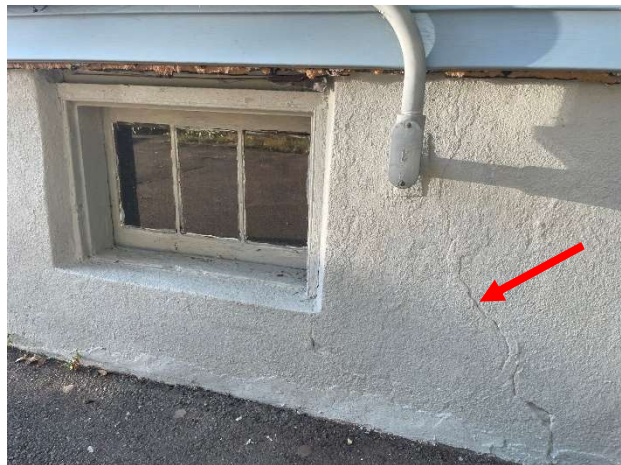
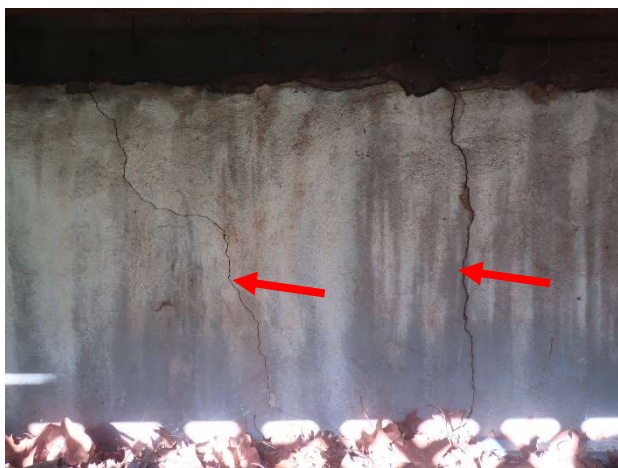
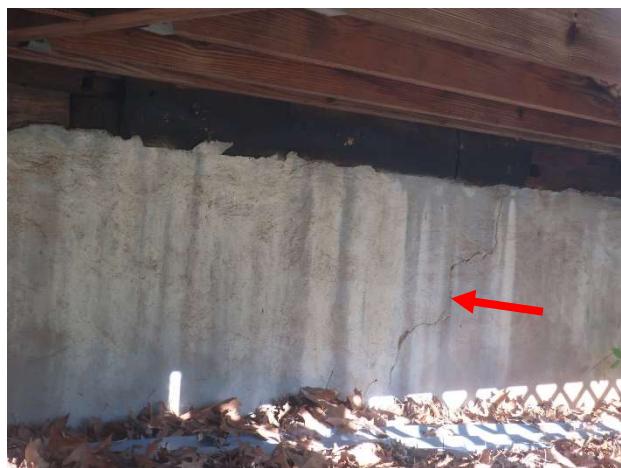
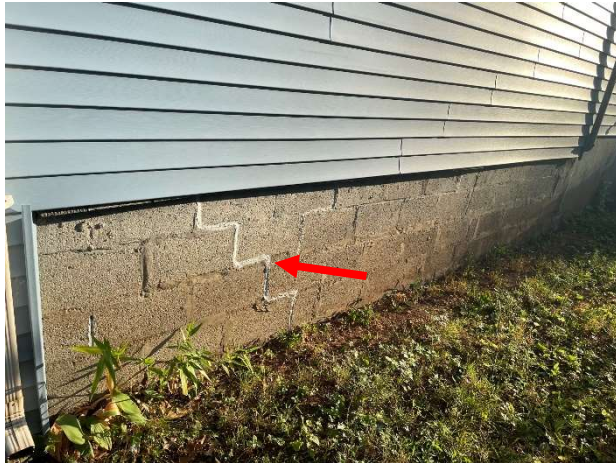
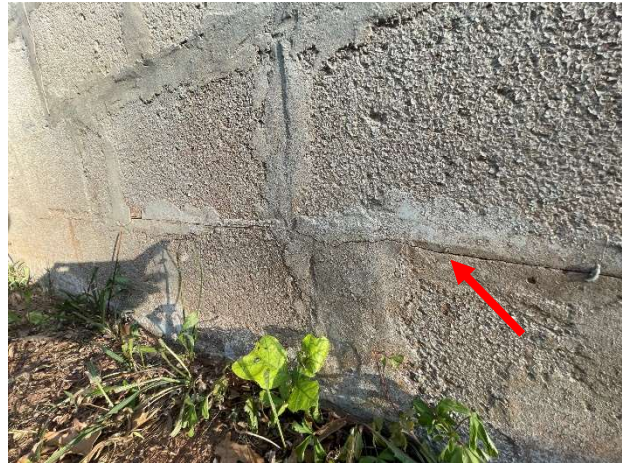
Condition 1: Existing concrete masonry unit (CMU) foundation wall appeared to have deteriorated. Loose mortar joints and damaged/deteriorated CMU blocks were observed in many locations inside the crawlspace. Multiple vertical, horizontal, and step cracks were observed on the exterior side of the foundation wall.

Observation #4.1: Existing concrete masonry unit (CMU) foundation wall appeared to have deteriorated. Loose mortar joints and damaged/deteriorated CMU blocks were observed in many locations inside the crawlspace. Multiple vertical, horizontal, and step cracks were observed on the exterior side of the foundation wall.

Implication: Weakened foundation and building structure.

Comments: Recommends hiring a contractor to perform the repair of the loose mortar joints and damaged CMU blocks.

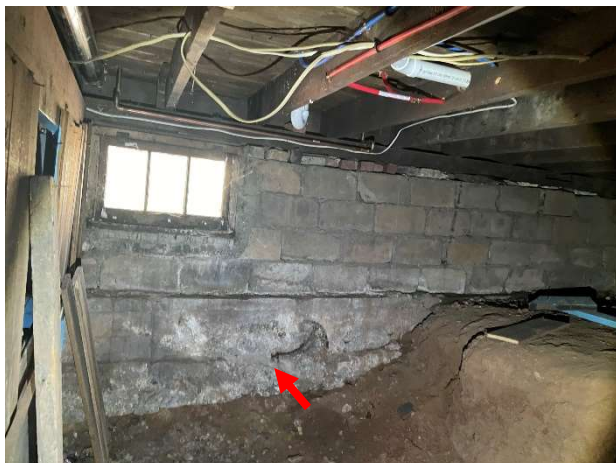
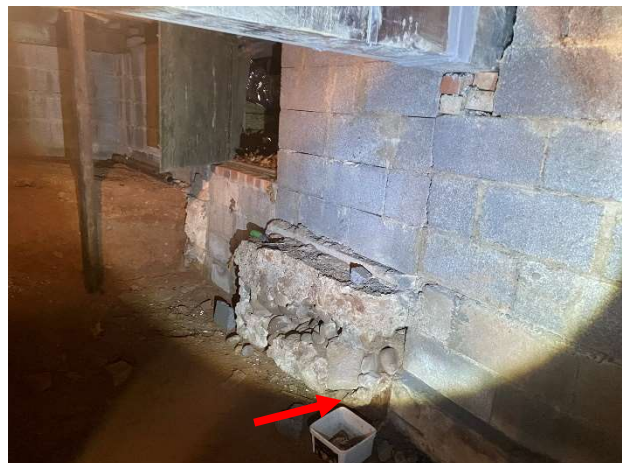
Condition 2: The soil in some areas of the crawlspace appeared to have previously been excavated or removed to create more headroom space in the crawlspace for mechanical equipment and other use. The removal of the soil exposed section of the foundation wall and footing for the CMU wall.

Observation #4.2: The soil in some areas of the crawlspace appeared to have previously been excavated or removed to create more headroom space in the crawlspace for mechanical equipment and other use. The removal of the soil exposed section of the foundation wall and footing for the CMU wall.

Implication: Removal of the soil in the crawl space will create an additional unbalance of soil lateral pressure on the foundation wall (soil at the exterior side will try to push the wall toward the interior side of the building). The foundation wall could also experience frost heaving when the top of soil elevation is lowered. Frost heaving of the foundation wall would damage the foundation and create building movement.

Comments: Recommends hiring a structural engineer to further evaluate the condition of the existing foundation wall and design for the required reinforcement and repair. Hire a contractor to perform all required structural repair work.

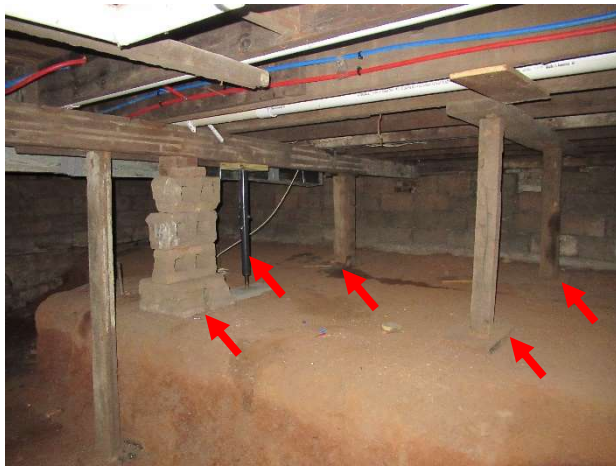
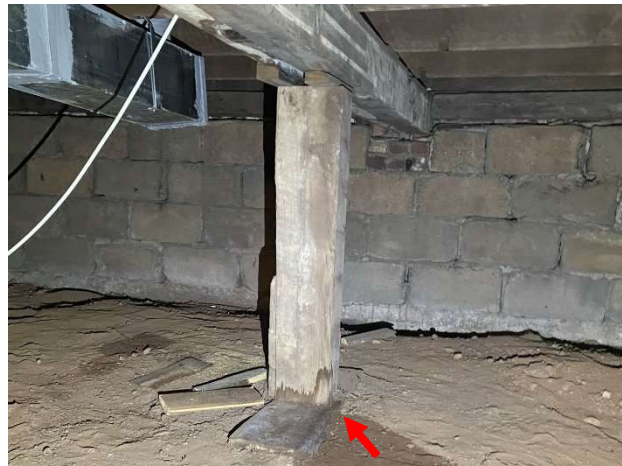
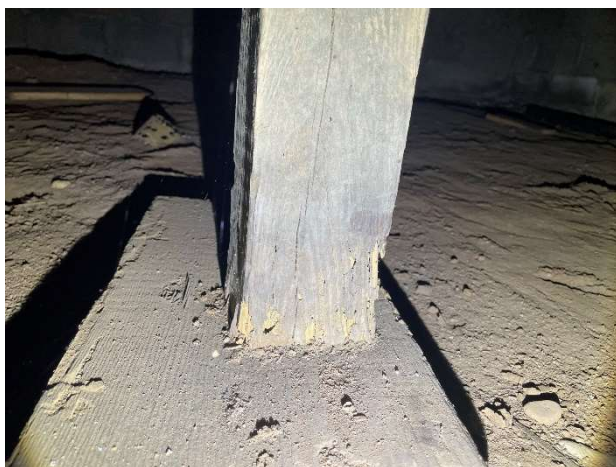
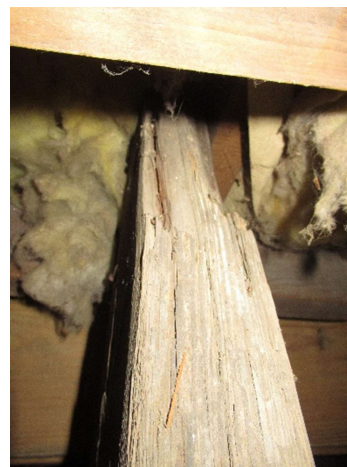
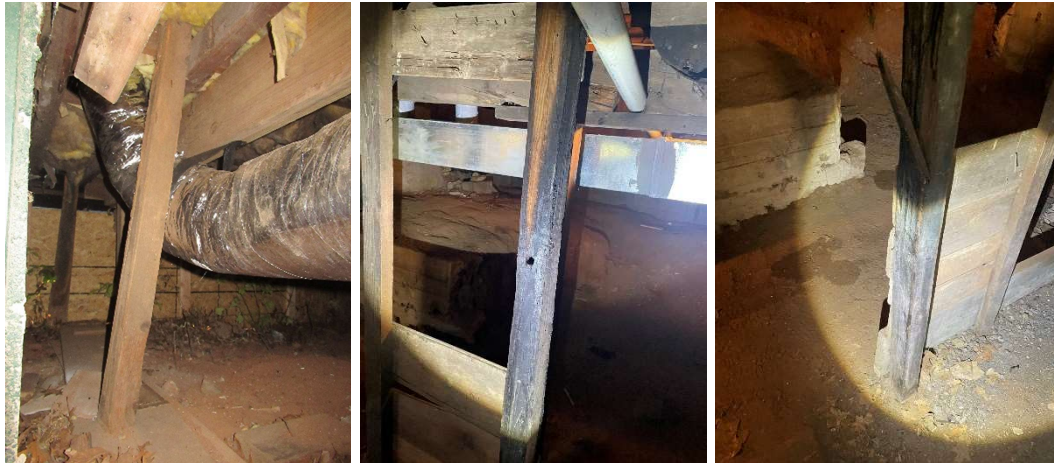
Condition 1: Many of the vertical structural supports in the crawl space were observed to be defected or improperly installed. Most of the vertical wood posts were bearing on soil without proper foundation. Some of the vertical wood posts were out of plumb. Some of the posts appeared to be damaged by wood destroying insects and some of the posts appeared to be damaged by fire. Improper stacked masonry block support was observed at one location. A few steel shoring posts were improperly installed.

Observation #4.3: Many of the vertical structural supports in the crawl space were observed to be defected or improperly installed. Most of the vertical wood posts were bearing on soil without proper foundation. Some of the vertical wood posts were out of plumb. Some of the posts appeared to be damaged by wood destroying insects and some of the posts appeared to be damaged by fire. Improper stacked masonry block support was observed at one location. A few steel shoring posts were improperly installed.

Implication: Weakened foundation and building structure. The installed vertical steel shoring posts imply possible previous structural stability issues which would require shoring.

Comments: Recommends hiring a structural engineer to further evaluate and design for the required reinforcement and repair. Hire a contractor to perform all required structural repair work.

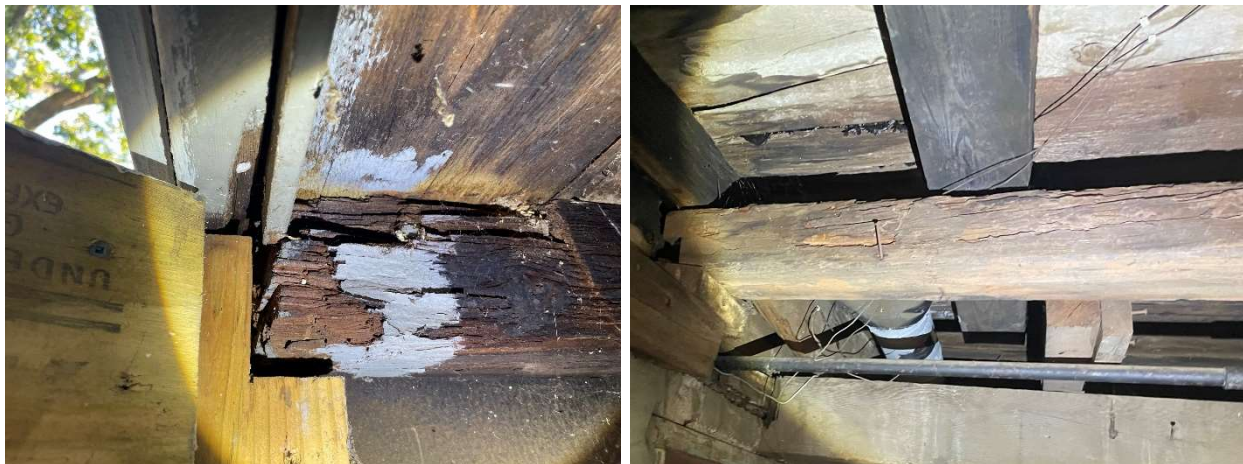
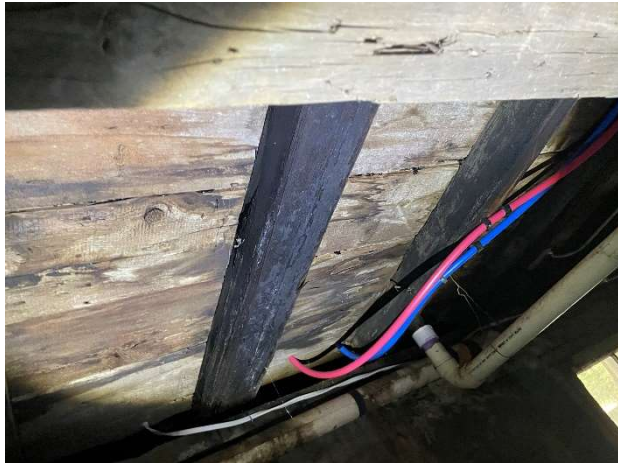
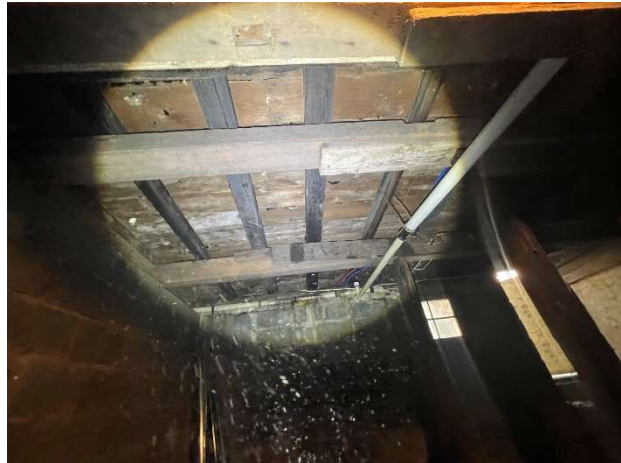
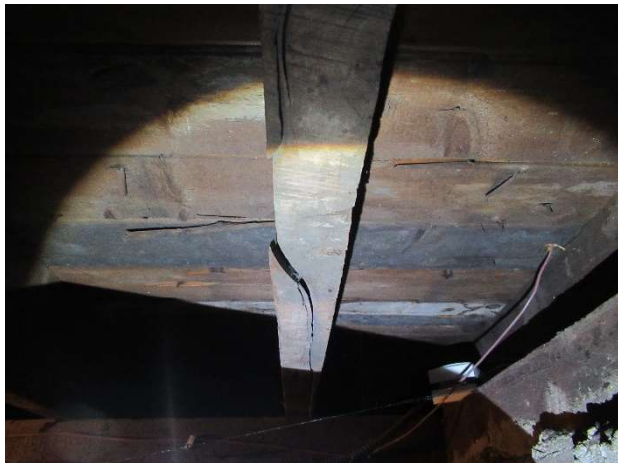
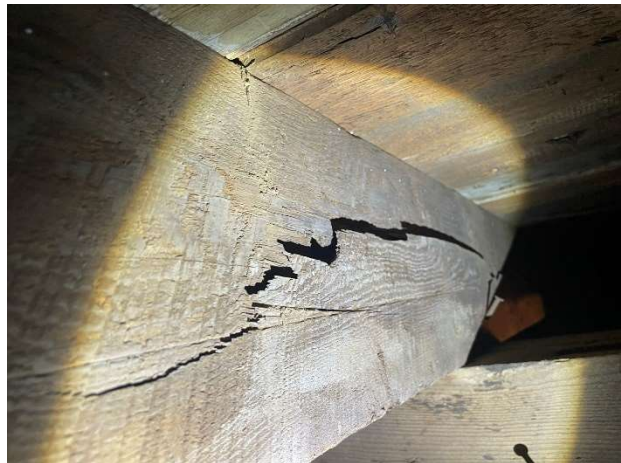
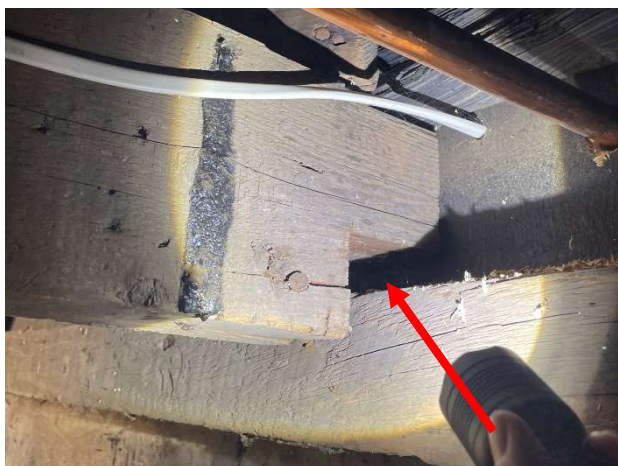
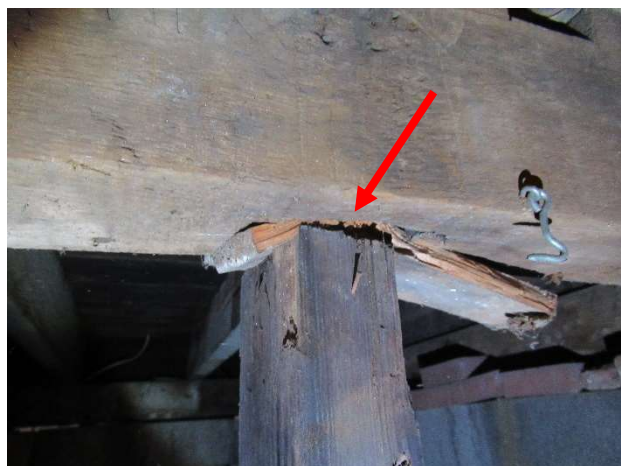
Condition 2: Many horizontal beams/joists in the crawlspace were damaged. Some of the beams appeared to be damaged by wood destroying insects and some of the beams appeared to be damaged by fire. Some of the beams have significant cracking. Multiple connections between the beams and the vertical supports were improper.

Observation #4.4: Many horizontal beams/joists in the crawlspace were damaged. Some of the beams appeared to be damaged by wood destroying insects and some of the beams appeared to be damaged by fire. Some of the beams have significant cracking. Multiple connections between the beams and the vertical supports were improper.

Implication: Weakened building structure.

Comments: Recommends hiring a structural engineer to further evaluate and design for the required reinforcement and repair. Hire a contractor to perform all required structural repair work.

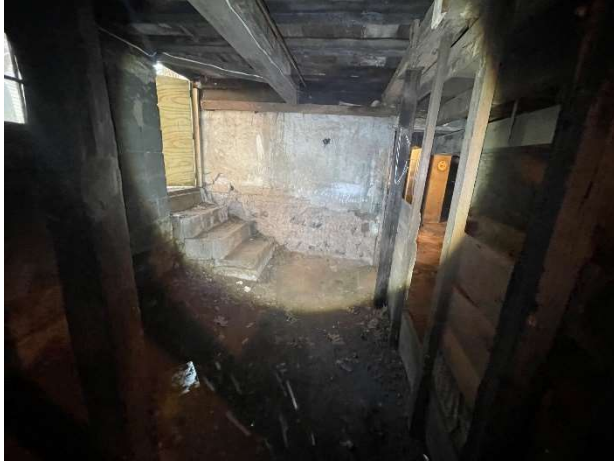
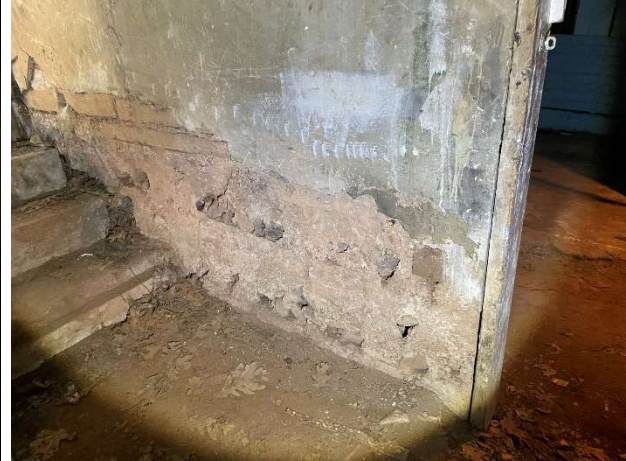
Condition 3: A section of the masonry wall, which appeared to support the structural beams, was significantly deteriorated.

Observation #4.5: A section of the masonry wall, which appeared to support the structural beams, was significantly deteriorated.

Implication: Weakened building structure.

Comments: Recommends hiring a structural engineer to further evaluate and design for the required reinforcement and repair. Hire a contractor to perform all required structural repair work.

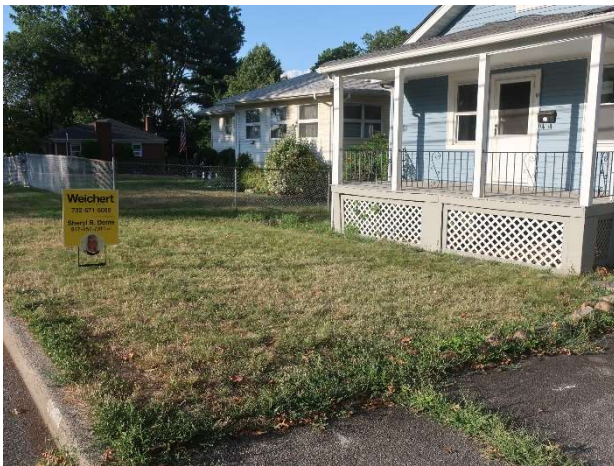
Condition: The lawn at the front of the house appears to be improperly graded and sloped toward the house.

Observation #5.1: The lawn at the front of the house appears to be improperly graded and sloped toward the house.

Implication: Water flow to the house. Possible damage to the foundation wall.

Comment: Recommends hiring a contractor to properly regrade the soil away from the house.

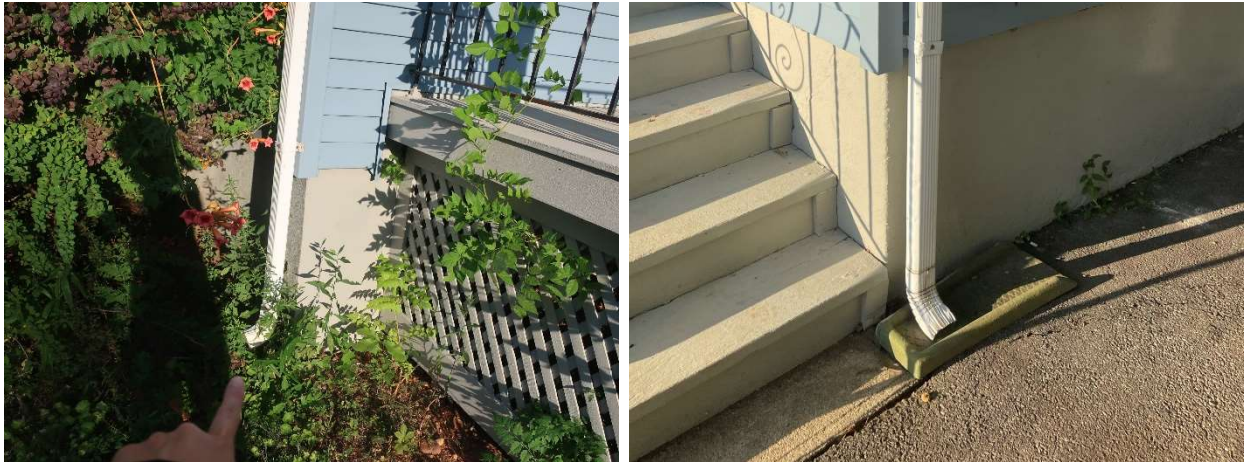
Condition: The discharge end of the downspouts was too close to the foundation of the building.

Observation #5.2: The discharge end of the downspouts was too close to the foundation of the building.

Implication: Possible damage to the foundation.

Comment: Recommends extending the discharge end of the downspout further away from the building.

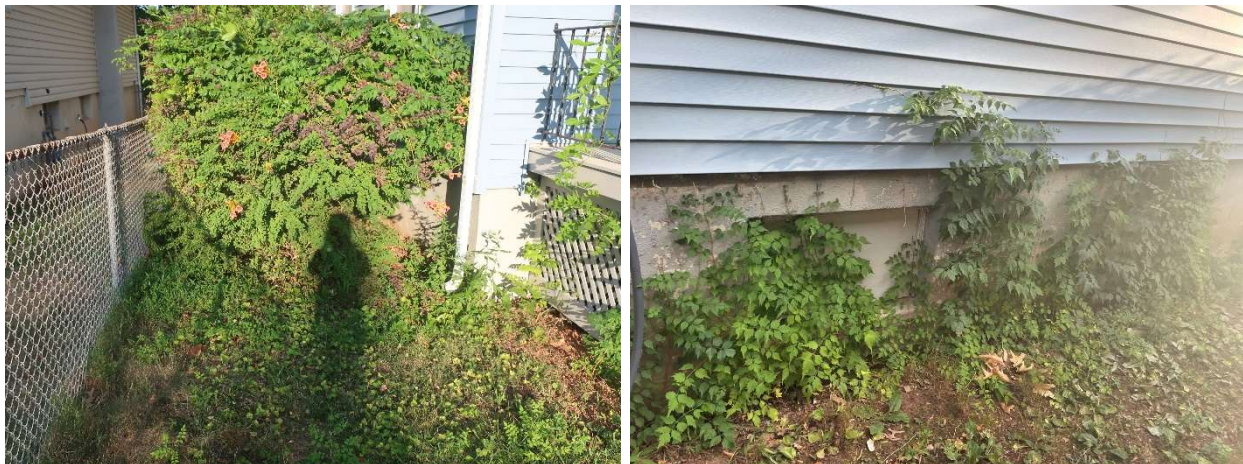
Observation #5.3: Plants are too close and are touching the foundation wall and siding.

Implication: Possible damage to the foundation wall and siding.

Comment: Recommends regular plant trimming and removal of plants growing on the wall.

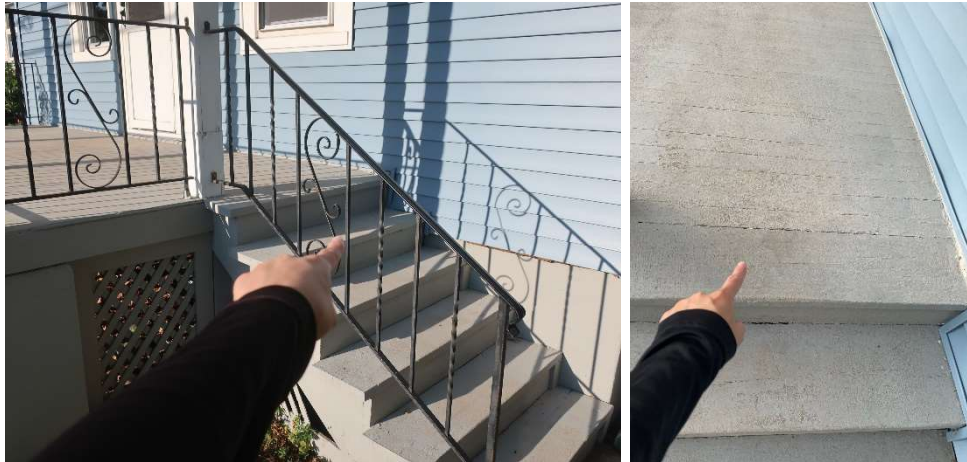
Condition 1: The stair railing at the front of the house was loose. The top step of the stair at the front of the house appeared to be loose.

Observation #5.4: The stair railing at the front of the house was loose. The top step of the stair at the front of the house appeared to be loose.

Implication: Possible falling hazard.

Comment: Recommends hiring a contractor to secure or replace the loose handrail and stair step.

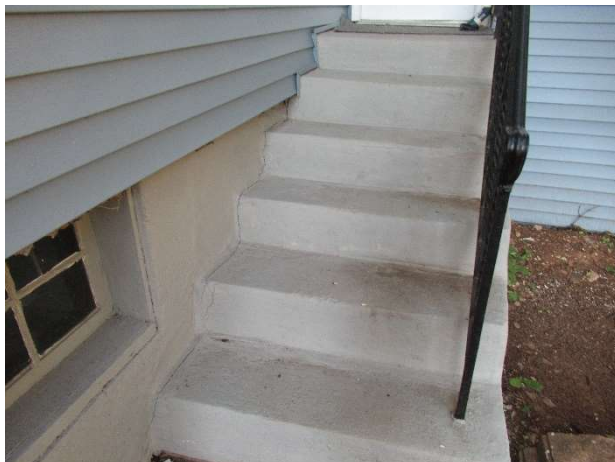
Condition 2: A crack was observed between that rear side stair and the building wall. The stair appears to be unlevel.

Observation #5.5: A crack was observed between that rear side stair and the building wall. The stair appears to be unlevel.

Implication: Possible previous building movement or settlement.

Comment: Recommends hiring a contractor to repair the crack and further evaluate the support of the stair. Install additional support as required.

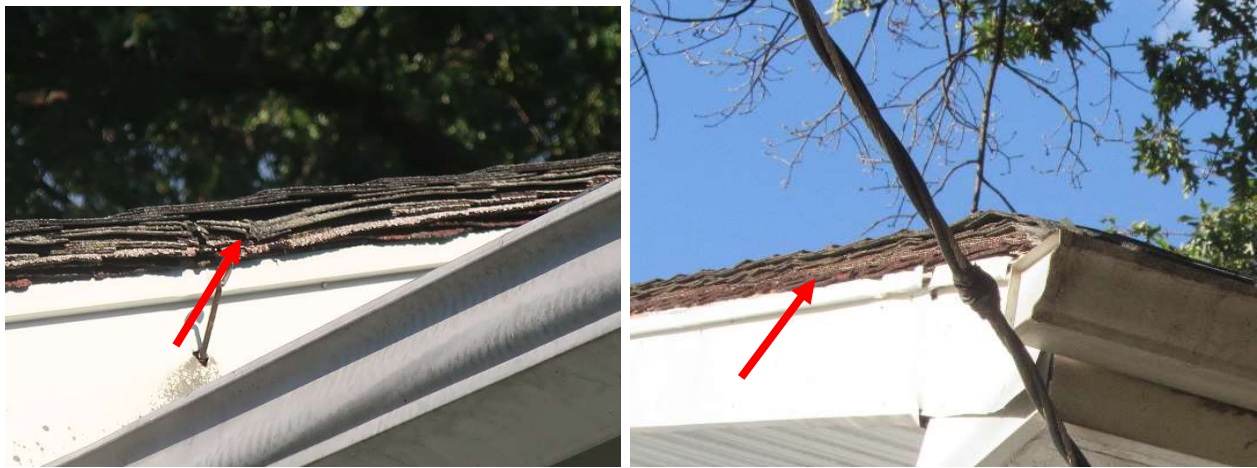
Condition 1: Improper asphalt shingle roofing installation. Multiple layers of asphalt shingles were installed over the old ones.

Observation #6.1: Improper asphalt shingle roofing installation. Multiple layers of asphalt shingles were installed over the old ones.

Implication: Possible water infiltration due to too many nail penetration in the shingle layers and added weight to the roofing framing.

Comments: Recommends hiring a roofing professional to further evaluate and replace the roofing as required.

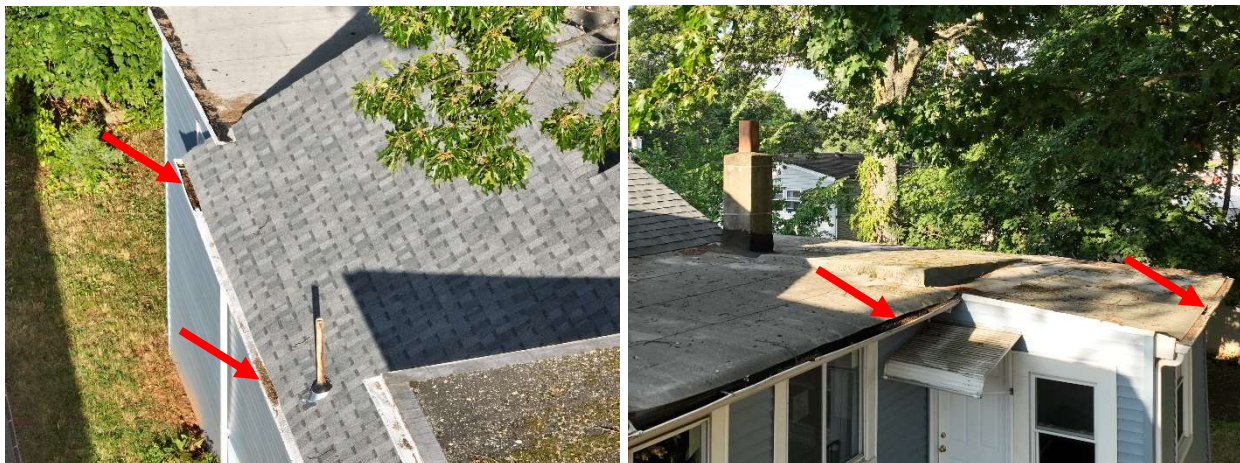
Condition: Obstructed/clogged gutter. The gutters around the building appear to be clogged by leaves and debris.

Observation #6.2: Obstructed/clogged gutter. The gutters around the building appear to be clogged by leaves and debris.

Implication: Possible rainwater back up, gutter sagging due to holding access water. Rainwater may overflow and drain down near the siding and foundation wall.

Comments: Recommends hiring a handyman to clean gutters and downspouts and provide regular inspection and maintenance.

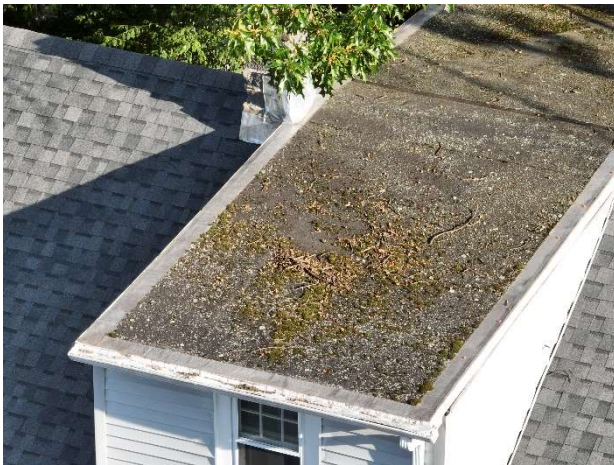
Condition 2: Debris and tree brunch were observed on the roof. Algae was growing on top of the flat roof.

Observation #6.3: Debris and tree brunch were observed on the roof. Algae was growing on top of the flat roof.

Implication: Possible roofing damage from falling of tree brunch. The saturated leaves on the roof would become compost. The compost from the leave in addition to the excessive moisture from the poor roof drainage would allow algae to grow.

Comments: Recommends cleaning the top of the roof and hiring a licensed roofer to further evaluate the roof condition.

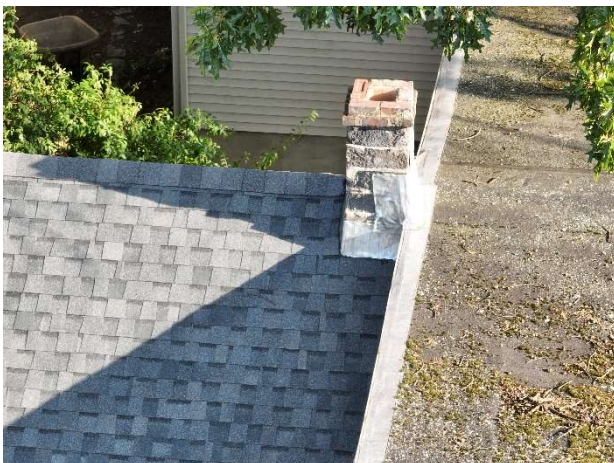
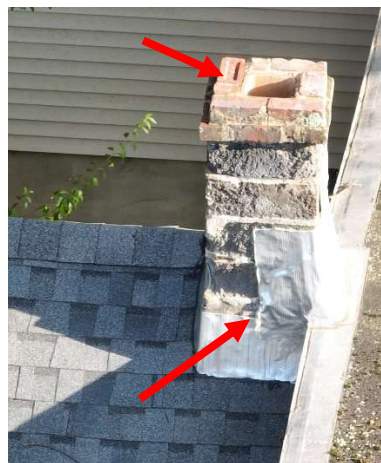
Condition: Missing chimney cap at the top of the chimney. The chimney crown appears to be constructed with brick and mortar instead of concrete, metal, or stone. Some of the masonry blocks on the chimney were deteriorated/spalled.

Observation #6.4: Missing chimney cap at the top of the chimney. The chimney crown appears to be constructed with brick and mortar instead of concrete, metal, or stone. Some of the masonry blocks on the chimney were deteriorated/spalled.

Implication: Possible for rainwater to enter the chimney flue. Brick and mortar chimney crown tends to deteriorate much quicker than other elements. Deteriorated masonry blocks would weaken the structural stability of the chimney.

Comments: Recommends hiring a chimney professional to install a chimney cap and perform the repair of the chimney as required.

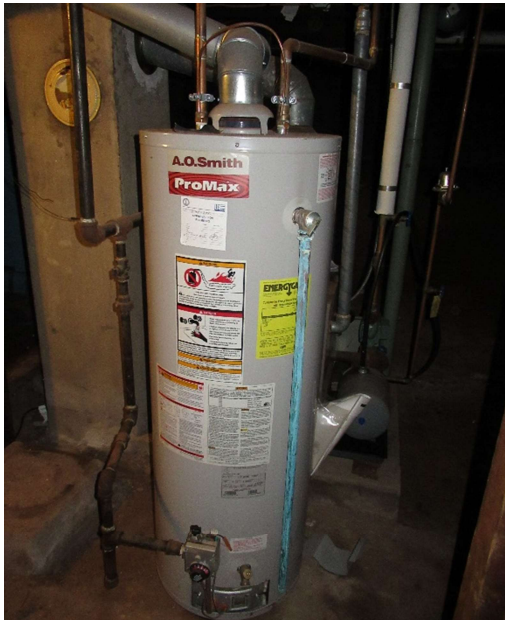
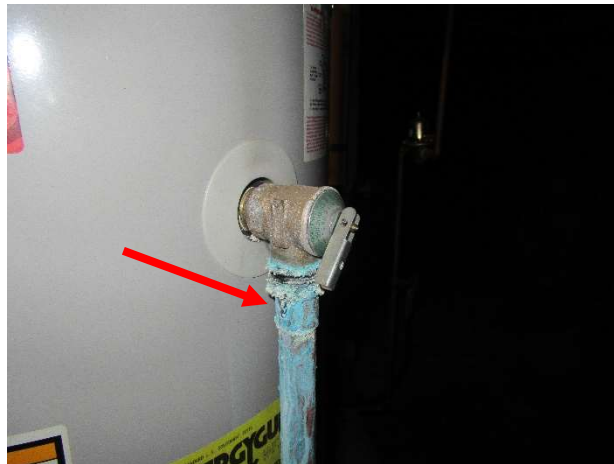
Condition: The water heater temperature and pressure relief valve (TPR) pipe was corroded with excessive patina stain.

Observation #7.1: The water heater temperature and pressure relief valve (TPR) pipe was corroded with excessive patina stain.

Implication: Possible water leakage

Comment: Recommends hiring a plumber to further evaluate and install a new TPR pipe.

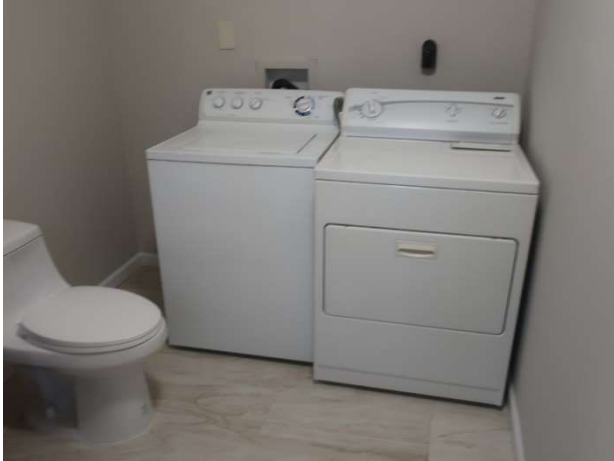
Condition: The washing machine appears to be inoperable at the time of the home inspection.

Observation #7.2: The washing machine appears to be inoperable at the time of the home inspection.

Comment: Recommends hiring an appliance professional for further evaluation and repair or replacement.

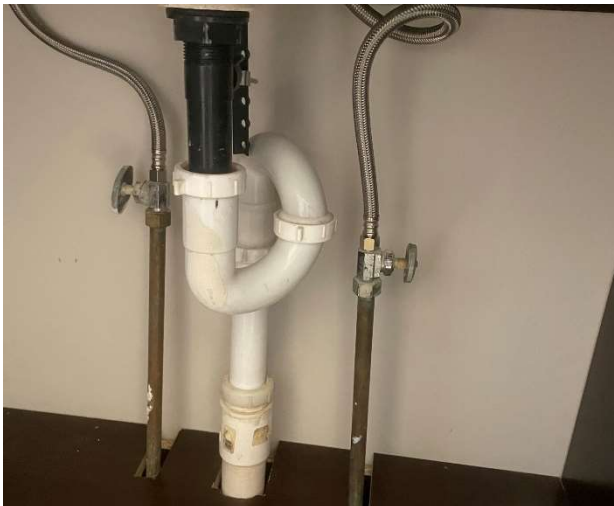
Observation #7.3: Improper S-trap installed under the bathroom sink.

Implication: Possible risk of sewer gases admission into the home.

Comment: Recommends hiring a qualified plumbing contractor to correct the drain line.

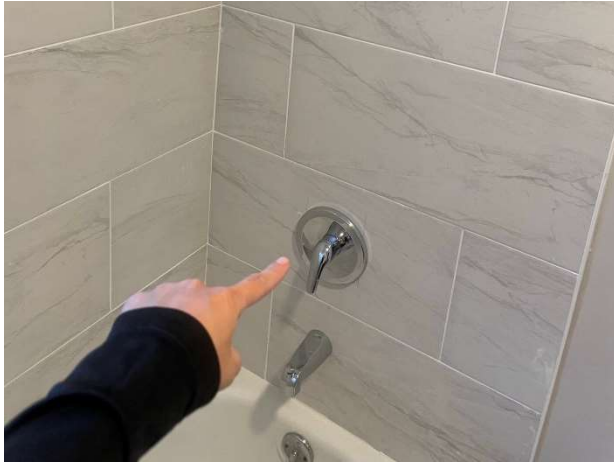
Condition: The bathroom shower faucet appeared to be inoperable.

Observation #7.4: The bathroom shower faucet was appeared to be inoperable.

Implication: The water supply system may be faulty.

Comment: Recommends hiring a plumber for further evaluation and repair.

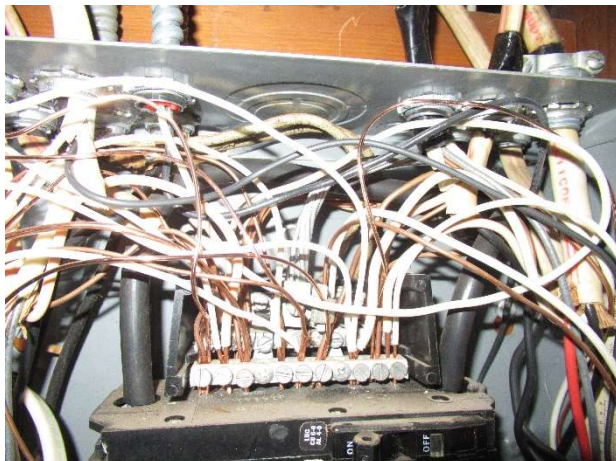
Condition 1: Multiple conductors inserted in one lug.

Implication: Possible safety hazard.

Comment: Recommends hiring an electrician for further evaluation, repair, and replacement.

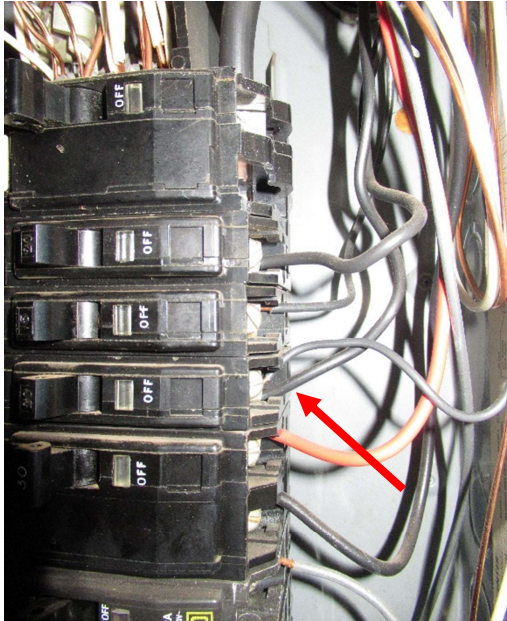
Condition 2: Improper double tapped electrical wires were observed in one of the breakers.

Observation #8.2: Improper double tapped electrical wires were observed in one of the breakers.

Implication: Multiple conductors in one lug may not be protected by the overcurrent protection device (OPD) or maybe over fused. Possible safety hazard.

Comment: Recommends hiring an electrician for further evaluation, repair, and replacement.

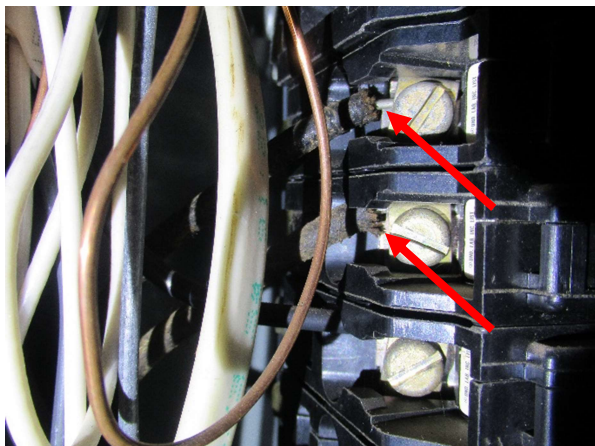
Condition 3: Aluminum wiring was observed in the electrical panel. The aluminum wires were also connected to an improper circuit breaker.

Observation #8.3: Aluminum wiring was observed in the electrical panel. The aluminum wires were also connected to an improper circuit breaker.

Implication: Possible safety hazard.

Comment: Recommends hiring an electrician for further evaluation, repair, and replacement.

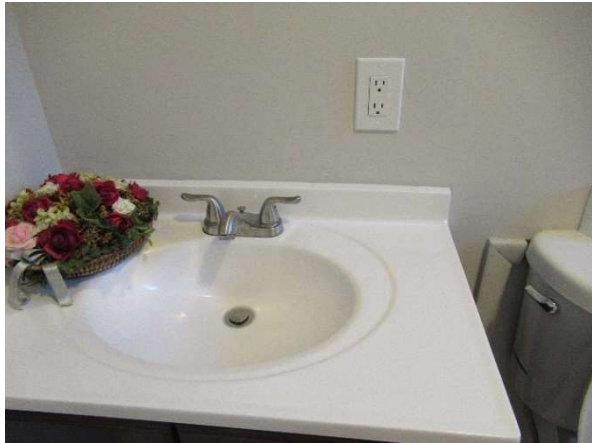
Observation #8.4: The electrical receptacle near the bathroom sink was not equipped with GFCI.

Implication: Possible safety hazard.

Comment: Recommends hiring an electrician for further evaluation, repair, and replacement.

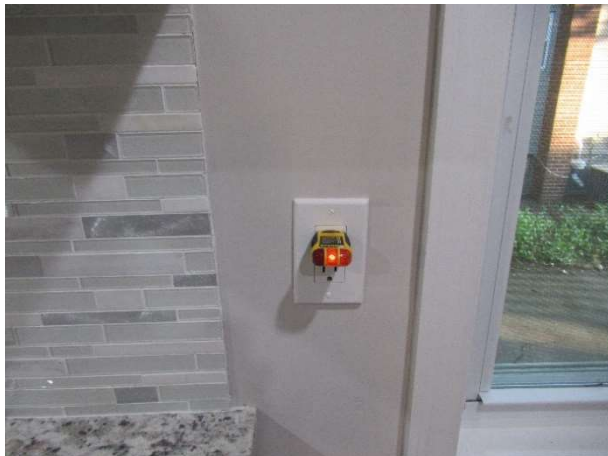
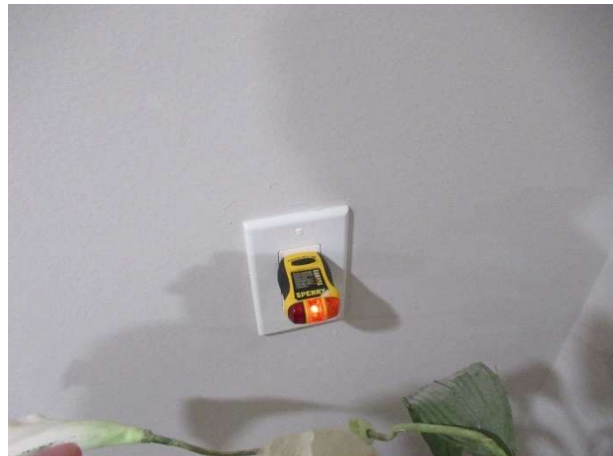
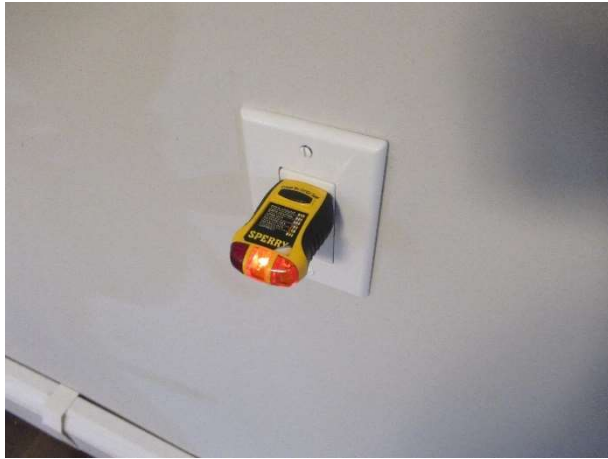
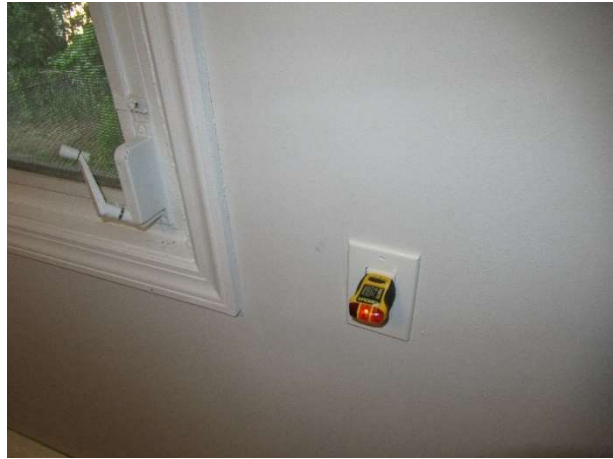
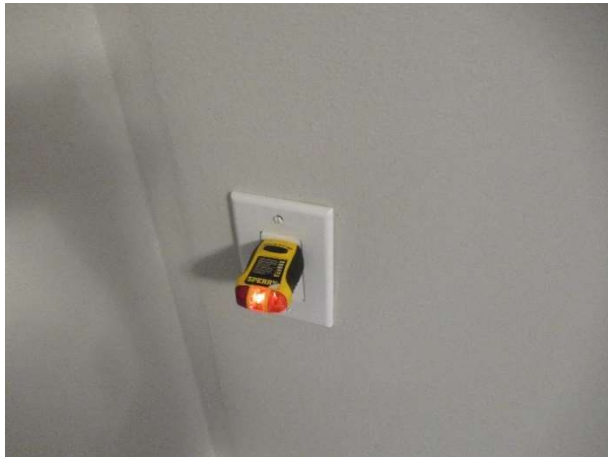
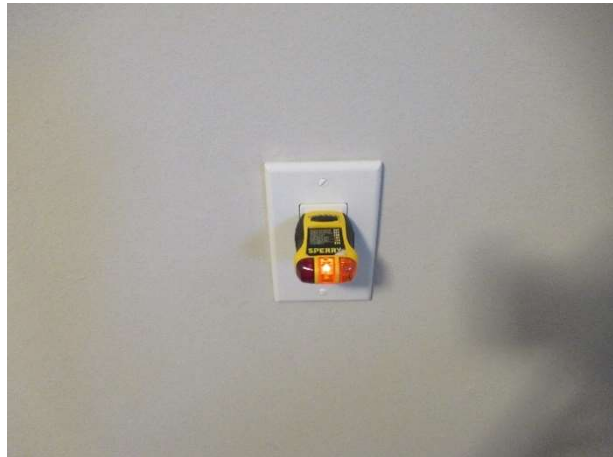
Condition 1: Multiple electrical outlets were not grounded.

Observation #8.5: Multiple electrical outlets were tested to have open ground.

Implication: The three-prong receptacle is not connected to an equipment grounding conductor. Possible safety hazard.

Comment: Recommends hiring an electrician for further evaluation, repair, and replacement.

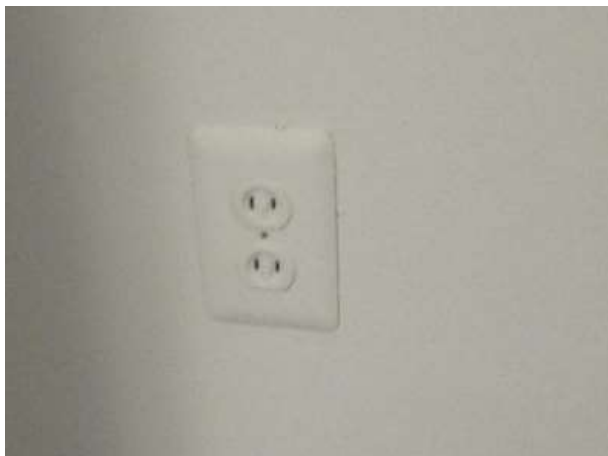
Observation #8.6: Many of the electrical outlets in the attic were not grounded.

Implication: Possible safety hazard.

Comment: Recommends hiring an electrician for further evaluation, repair, and replacement.

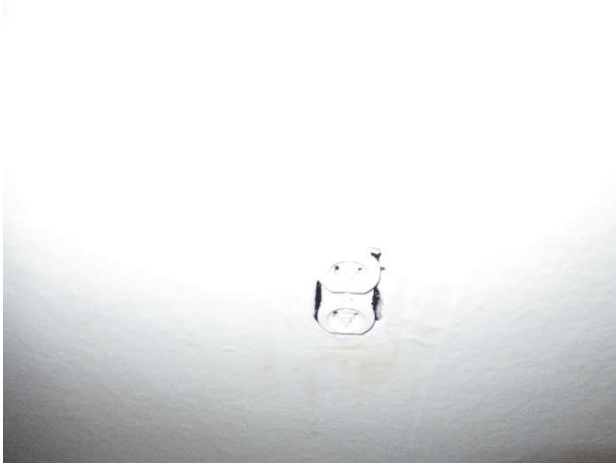
Condition 2: A few electrical outlets in the attic were missing cover plates.

Observation #8.7: A few electrical outlets in the attic were missing cover plates.

Implication: Possible safety hazard.

Comment: Recommends hiring an electrician for further evaluation, repair, and replacement.

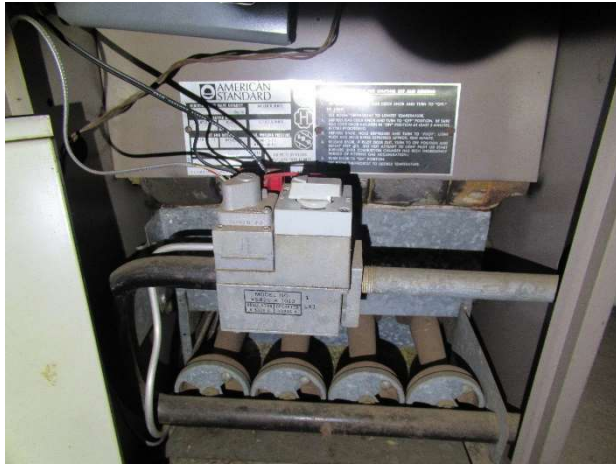
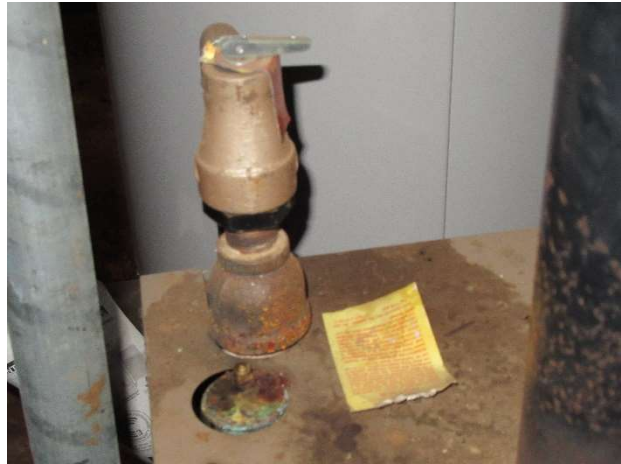
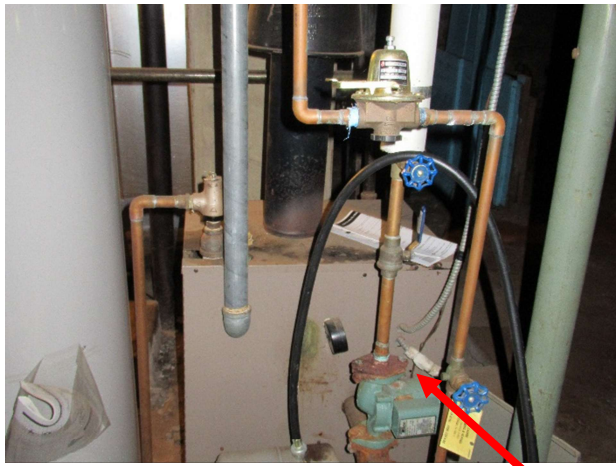
Condition: The boiler components appeared to be severely rusted. The boiler is near the end of its service life. The thermostat was not operable.

Observation #9.1: The boiler components appeared to be severely rusted. The boiler is near the end of its service life. The thermostat was not operable.

Comment: Recommends installing a new boiler.

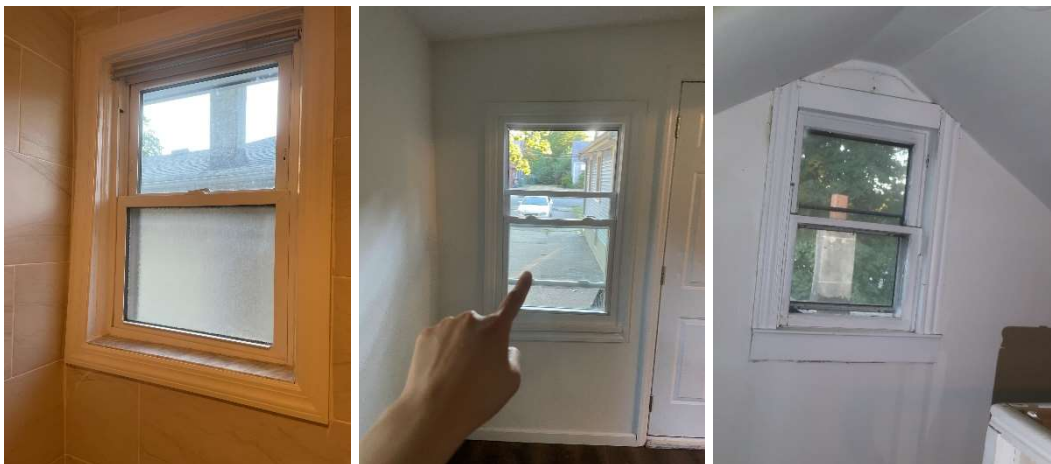
Condition: Two hung windows on the 1st floor were broken. The window panes were not able to stay open. Multiple windows in the attic space were not operable.

Observation #11.1: Two hung windows on the 1st floor were broken. The window panes were not able to stay open. Multiple windows in attic space were not operable.

Implication: Possible safety hazard from falling window. Air quality and health issue if windows are not operable.

Comment: Recommends hiring a window professional to repair or replace the broken and inoperable windows.

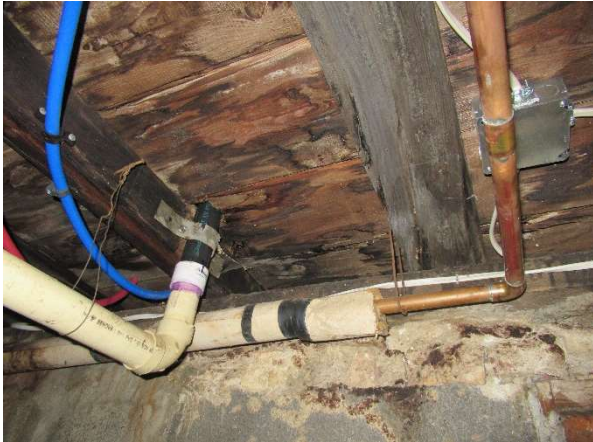
Condition: Water damage was observed at the underside first floor planks.

Observation #11.2: Water damaged was observed at the underside first floor planks.

Implication: Possible weakened floor.

Comment: Hiring a contractor to remove and replace the damaged floor planks.

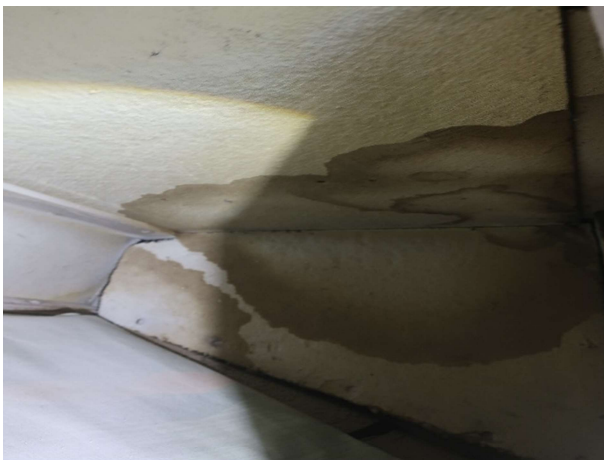
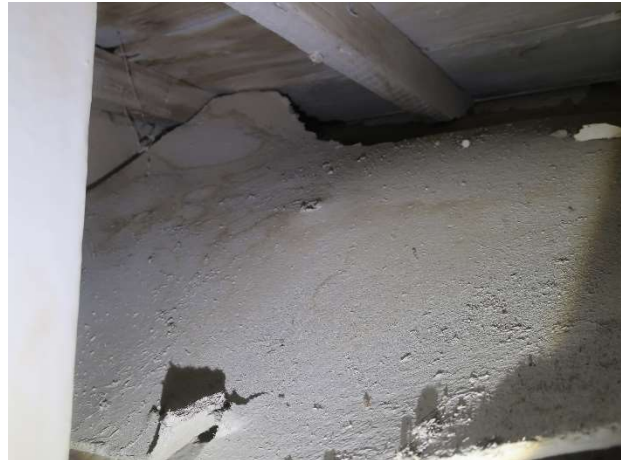
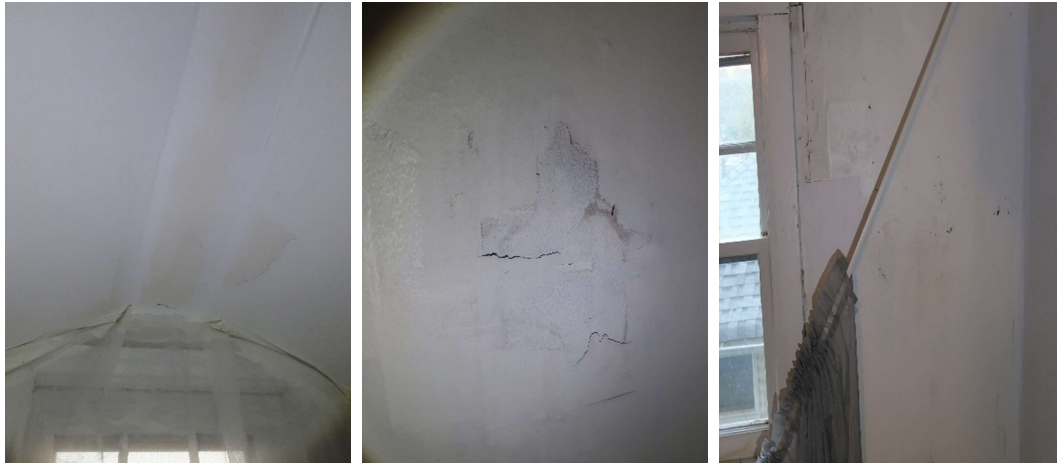
Condition: Water stains and damaged interior finishes were observed in many locations in the attic space.

Observation #11.3: Water stains and damaged interior finishes were observed in many locations in the attic space.

Implication: Possible damaged roofing and water infiltration. Possible weakened roof and wall structural components from water damage.

Comment: Recommends hiring an electrician for further evaluation, repair, and replacement.
