Home Inspection Report

Prepared for: [REDACTED]

Prepared By: Zoey Tham

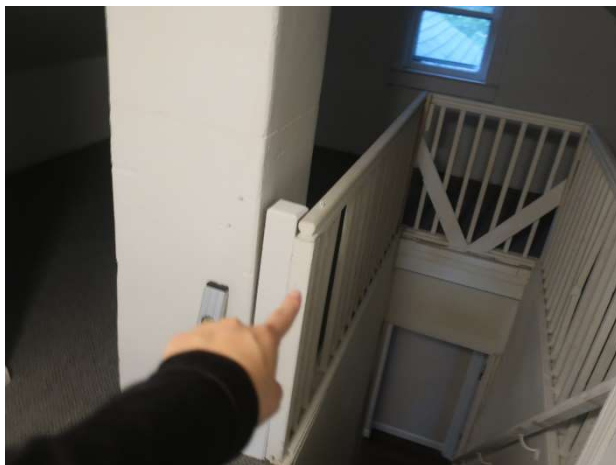
Condition: The guardrail around the stair to the attic space was loose.

Observation #11.4: The guardrail around the stair to the attic space was loose.

Implication: Possible falling hazard.

Comment: Recommends hiring a contractor to secure or replace loose guardrail.

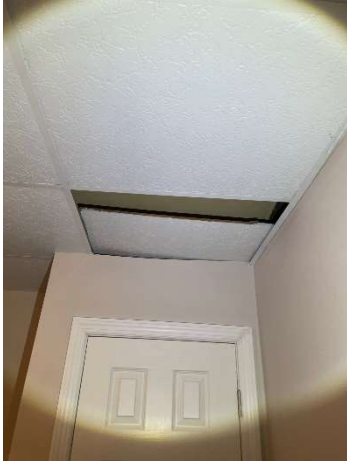
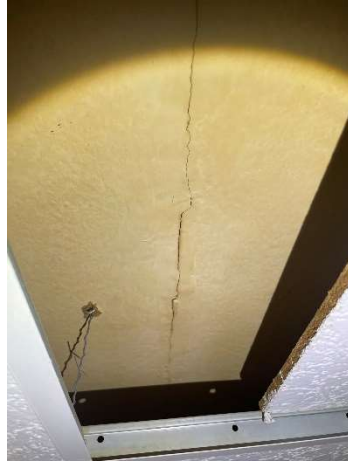
Condition: A crack was observed in the old ceiling finish above the existing drop ceiling.

Observation #11.5: A crack was observed in the old ceiling finish above the existing drop ceiling.

Comment: Recommends hiring a contractor to remove other drop ceiling panels to further evaluate.

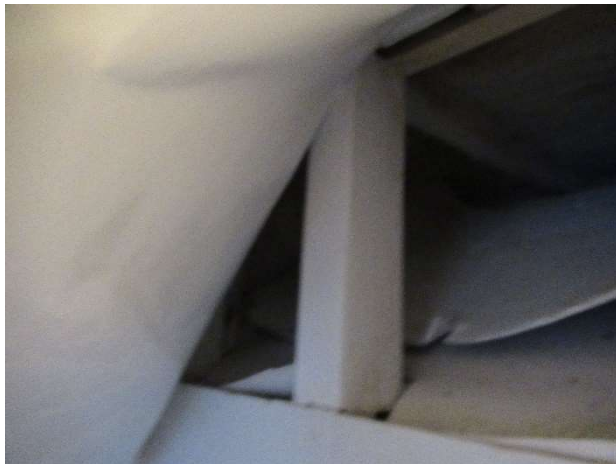
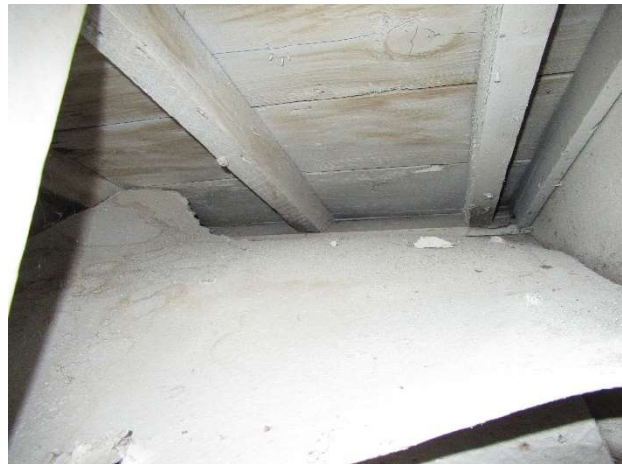
Condition: Attic and roof insulation appeared to be missing and incomplete in some areas of the attic.

Observation #12.1: Attic and roof insulation appeared to be missing and incomplete in some areas of the attic.

Implication: Possible decrease in comfort and increase in energy consumption.

Comments: Recommends hiring a contractor to confirm if insulation is installed. If not, recommends installing the missing insulation.
