# Home Inspection Report

████████████████████ Hoboken NJ 07030

**Inspection Date:** 6/9/2022

**Prepared By:** Zoey Tham, #24GI00217600

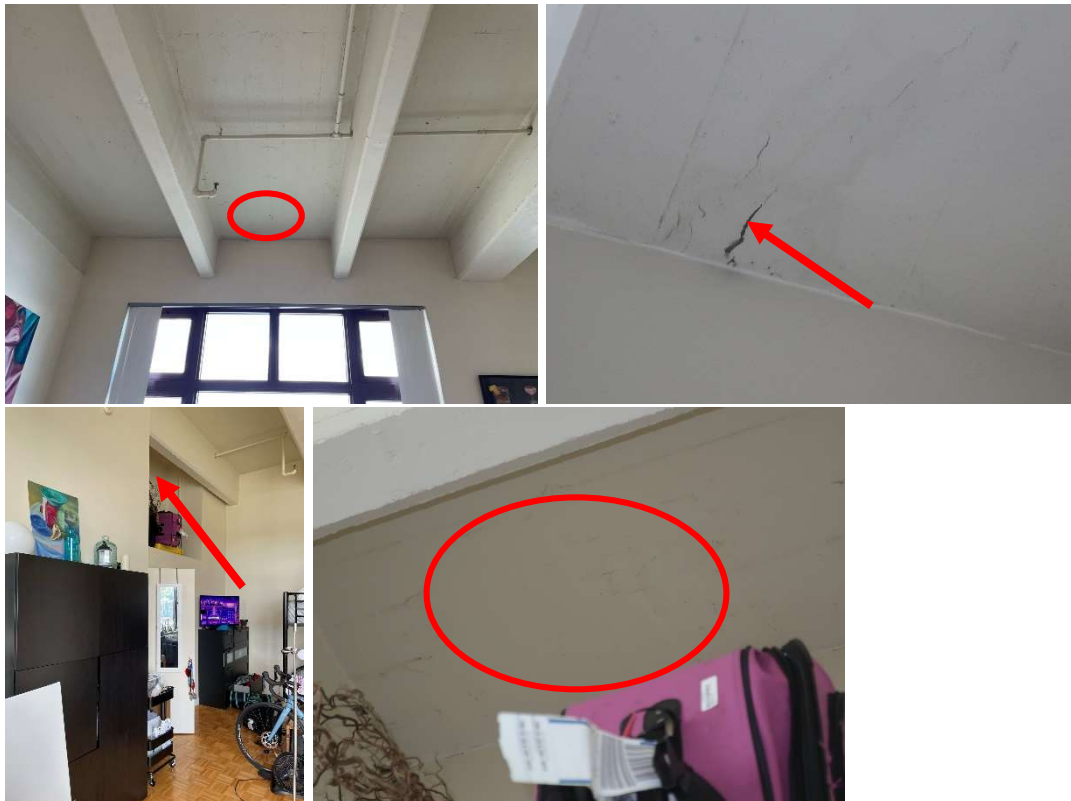
Condition: Two previous patch repairs were observed in the concrete ceiling. A crack was observed at the concrete patch near the window.

Observation #4.1: Two previous patch repairs were observed in the concrete ceiling. A crack was observed at the concrete patch near the window.

Implication: Concrete ceiling had previously cracked or damaged. Possible water leakage if crack in the patch near the window was caused by water infiltration.

Comments: Recommends consulting the seller agent regarding the history of the patches and if water leakage was previous reported. Hire a contractor to further evaluate and repair the cracked concrete.

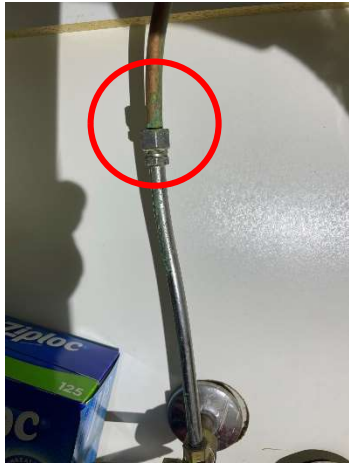
Condition: Minor patina stain was observed on the water line under the kitchen sink.

Observation #5.1: Minor patina stain was observed on the water pipe under the kitchen sink.

Implication: Patina stain indicates excessive moisture

Comment: Recommends cleaning patina corrosion and keeping the copper pipe dry

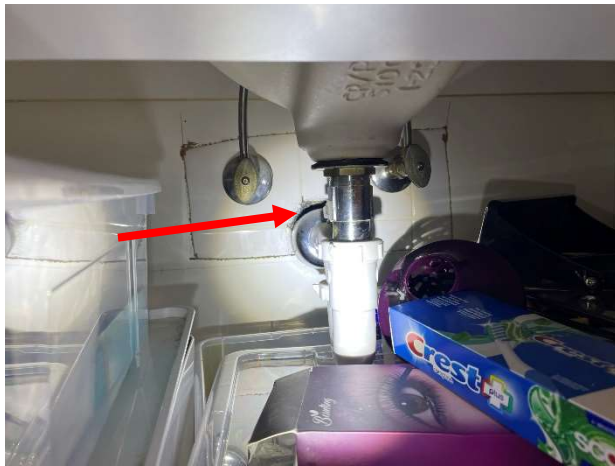
Condition: The hole in the wall is too large for the drainage pipe under the bathroom sink. A gap was visible.

Observation #5.2: The hole in the wall is too large for the drainage pipe under the bathroom sink. A gap was visible.

Comment: Recommends sealing the holes around plumbing pipe.

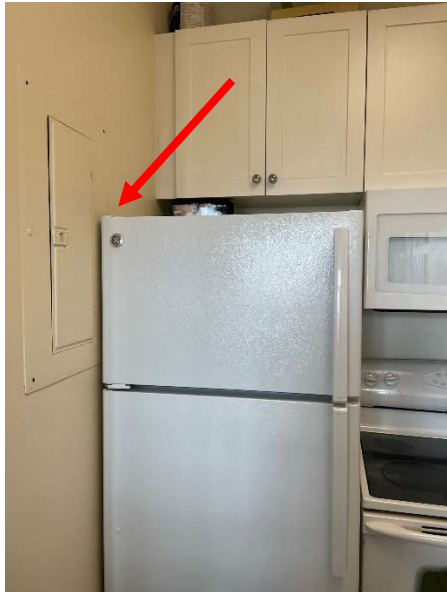
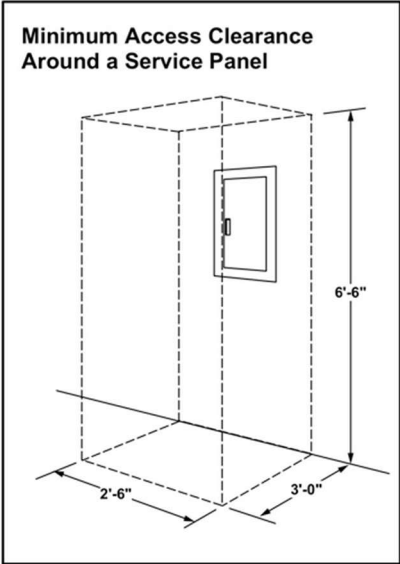
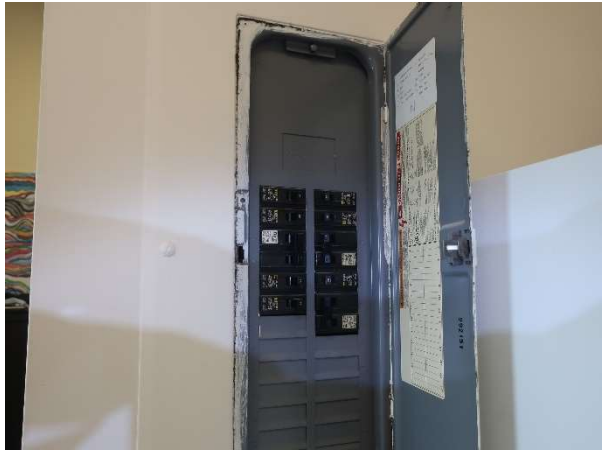
Condition: Due to inadequate clearance around the electrical panel, we were unable to remove the electrical panel cover and perform the inspection.

Observation #6.1: Due to inadequate clearance around the electrical panel, we were unable to remove the electrical panel cover and perform the inspection.

Comment: Recommends provide adequate clearance around electrical panel for future examination, servicing, adjustment or maintenance.

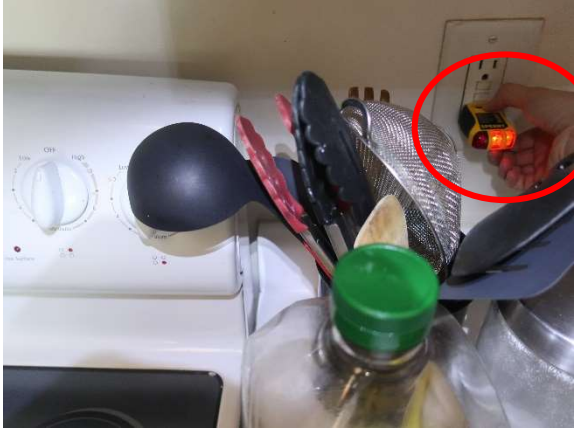
Observation #6.2: The GFCI in the kitchen was not tripping when tested.

Implication: Possible safety hazard

Comment: Recommends hiring an electrician for further evaluation, repair, and replacement

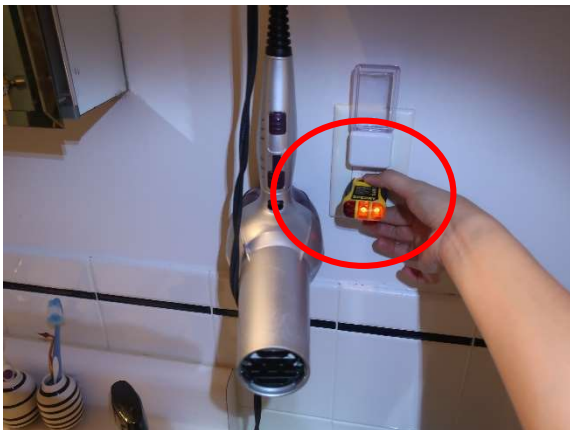
Observation #6.3: The GFCI in the bathroom was not tripping when tested.

Implication: Possible safety hazard

Comment: Recommends hiring an electrician for further evaluation, repair, and replacement

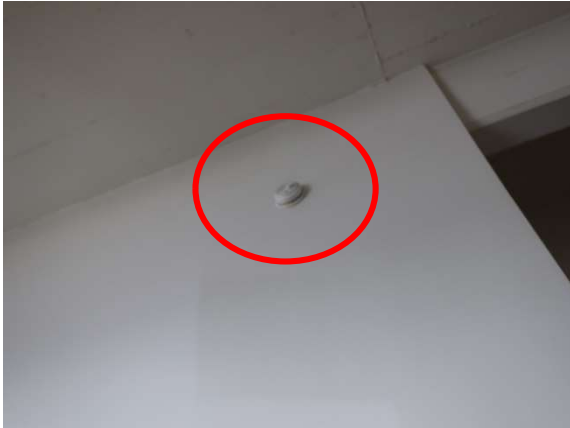
Condition: An alarm device was observed on the wall. We could not verify if the device can detect both smoke and carbon monoxide

Observation #6.4: An alarm device was observed on the wall. We could not verify if the device can detect both smoke and carbon monoxide

Comment: Recommends consulting the seller for more information. Install addition alarm device if existing device does not detect both smoke and carbon monoxide.

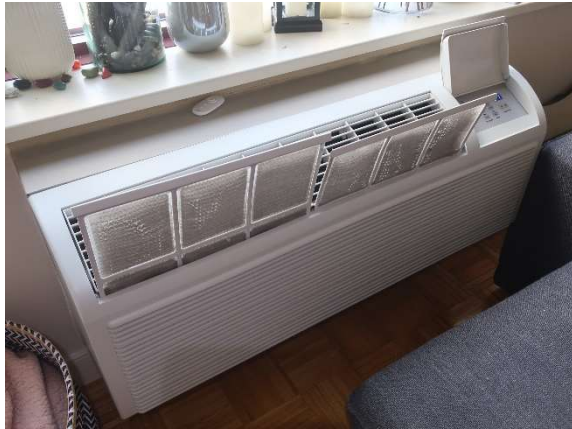
Condition: Dirty air filters in the PTAC unit.

Observation #7.1: Dirty air filters in the PTAC unit.

Implication: Dirty filters slow down airflow through PTAC unit, restrict air flow and place additional strain on PTAC unit

Comment: Recommends regular cleaning and maintenance for PTAC unit

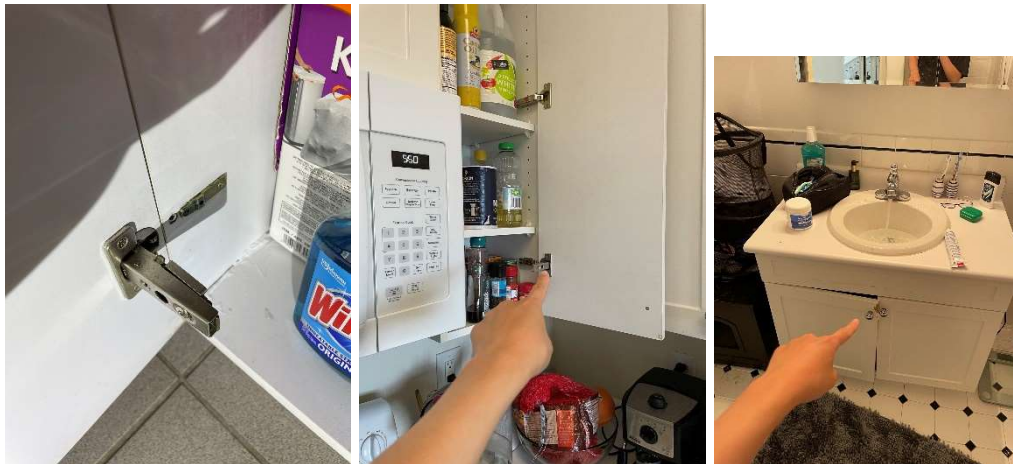
Observation #8.1: Multiple cabinet door hinges were loose or broken.

Comment: Recommends properly securing the loose hinges and replacing the broken hinges.

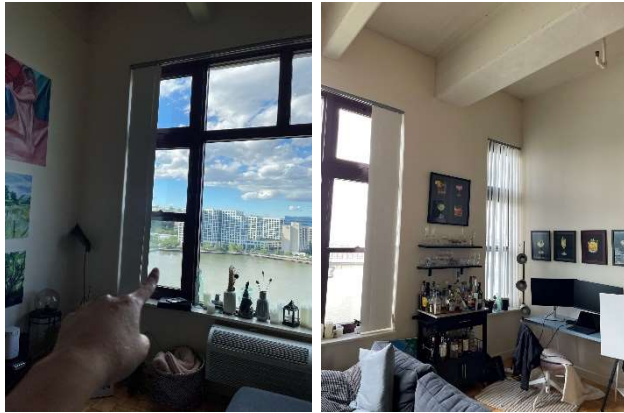
Condition: All of the single hung windows were difficult to open and close. Minor damage and small hole were observed in the window screens.

Observation #8.2: All of the single hung windows were difficult to open and close. Minor damage and small hole were observed in the window screens.

Implication: Possible accumulation of dirt or other debris on window frames. Possible damaged windows.

Comments: Recommends hiring a window professional to further evaluate and repair as required.

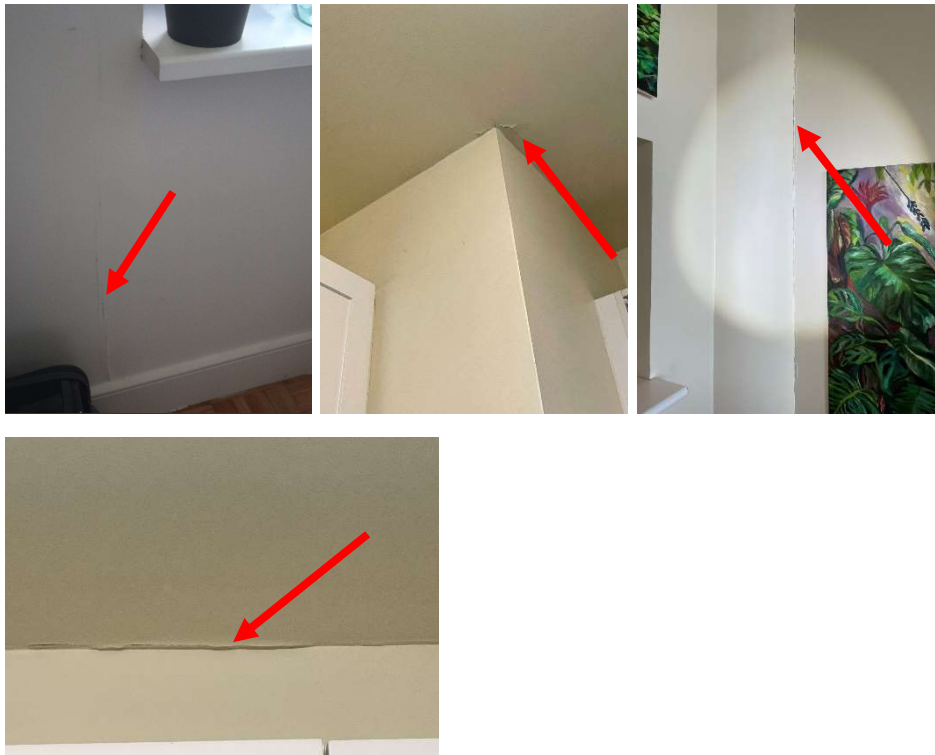
Condition: Minor cracks were observed in the ceiling and wall finishes.

Observation #8.3: Minor cracks were observed in the ceiling and wall finishes.

Comments: Recommends hiring a handyman to repair and repaint the finishes.

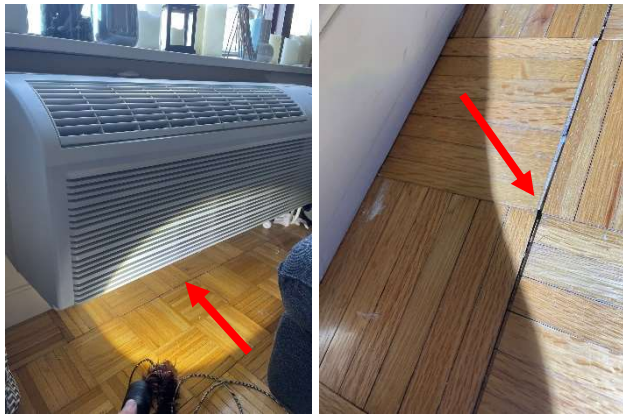
Condition: A gap was observed between the parquet floor tiles.

Observation #8.4: A gap was observed between the parquet floor tiles.

Comment: Recommends infilling the gaps.

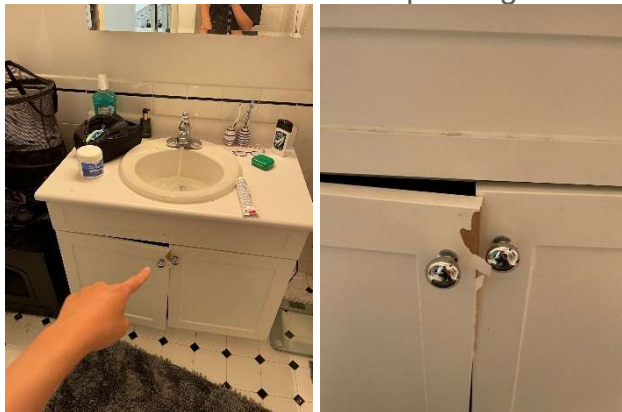
Observation #8.5: Minor paint peeling was observed on the bathroom sink cabinet door.

Comments: Recommends repainting the door.

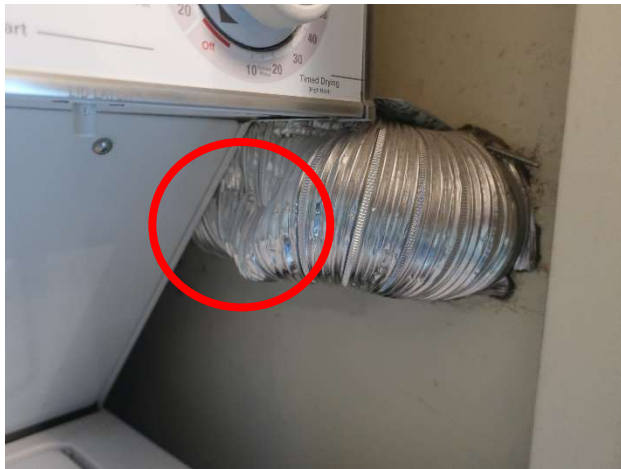
Condition: The dryer exhaust duct was made of flexible foil. The exhaust duct is dented and damaged.

Observation #9.1: The dryer exhaust duct was made of flexible foil. The exhaust duct is dented and damaged.

Implication: Possible trap lint, build-up and debris inside duct. A clogged duct can cause ineffective drying, higher energy bills and reducing lifespan of the appliance.

Comment: Recommends hiring a handyman for duct repair or replacement.
