Home Inspection Report

Prepared for: [REDACTED]

Prepared By: Zoey Tham

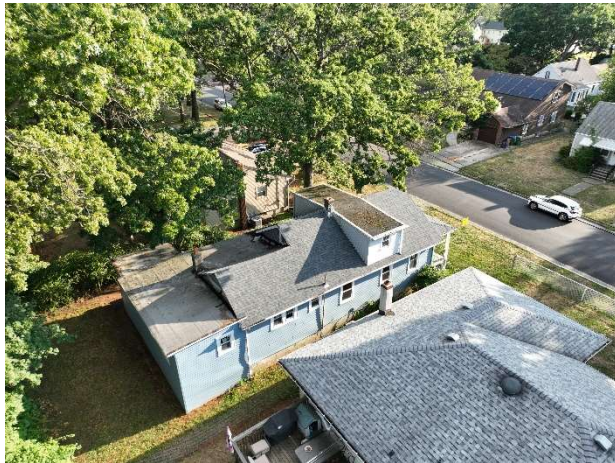
Observation #6.1: Improper asphalt shingle roofing installation. Multiple layers of asphalt shingles were installed over the old ones.

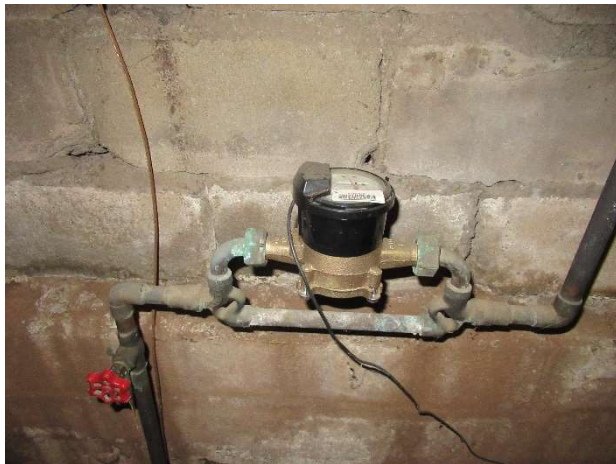
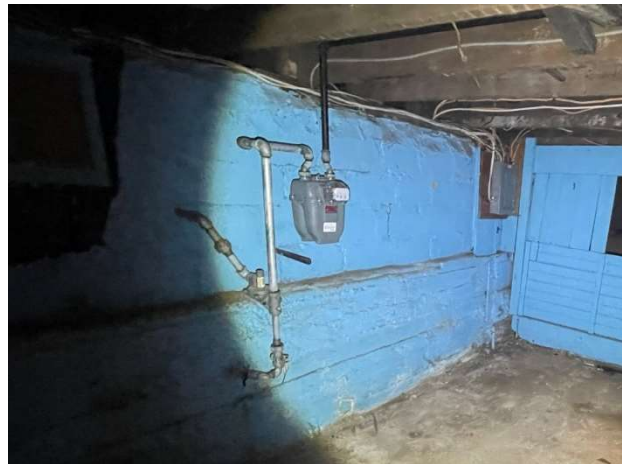
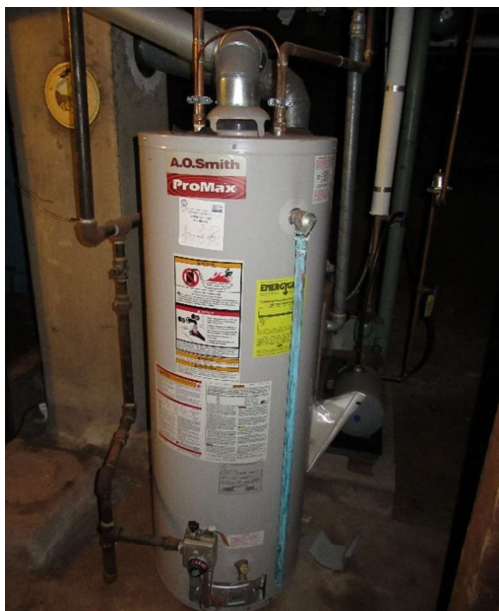
Location of main water shut-off valve: Basement

Location of gas shut-off valve: Basement

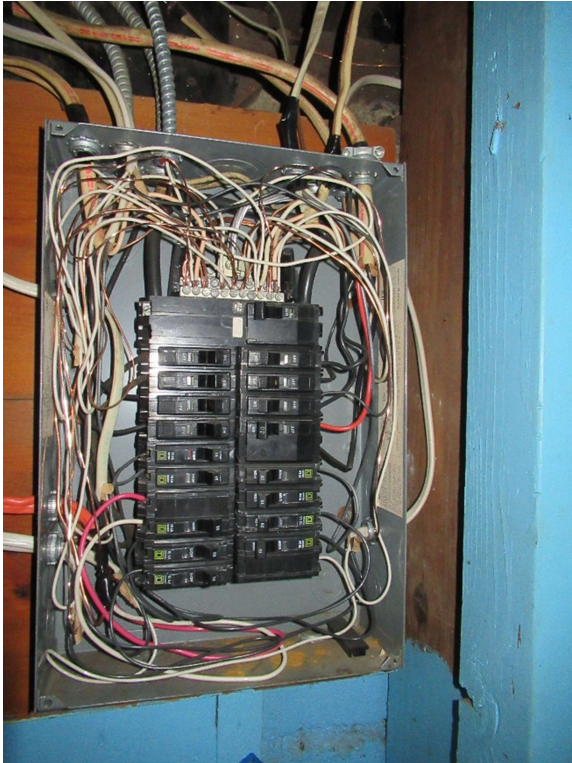
Location of the main disconnect: Basement

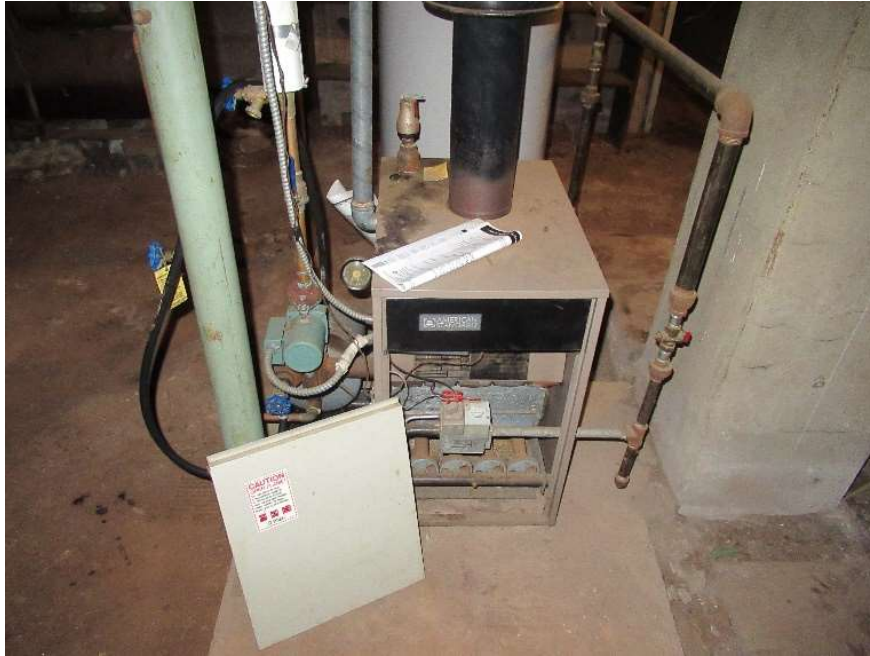
Heating energy source(s): Natural gas

Primary Heating system: Boiler

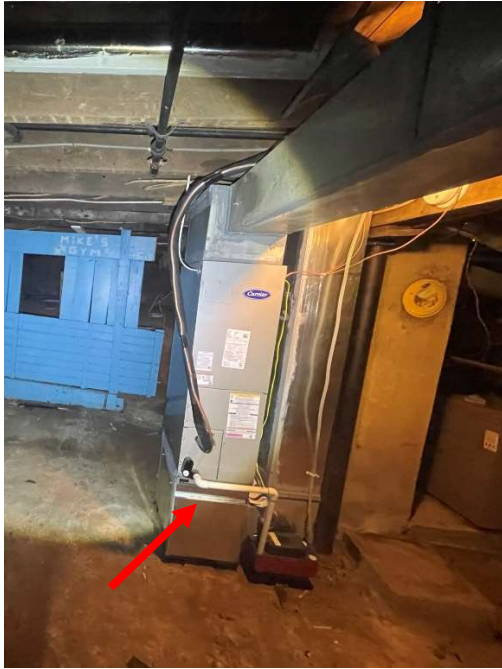
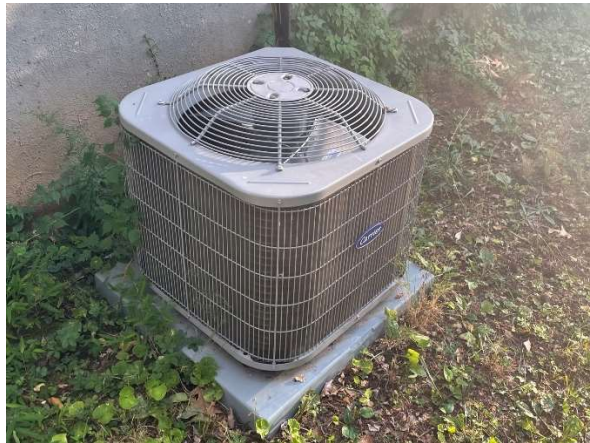
Cooling energy source(s): Electricity

Cooling equipment type: Central Air
